APP Conference

John Daley PE PAMP Engineering Manager

Port of Alaska - Anchorage

Port of Alaska Modernization Program

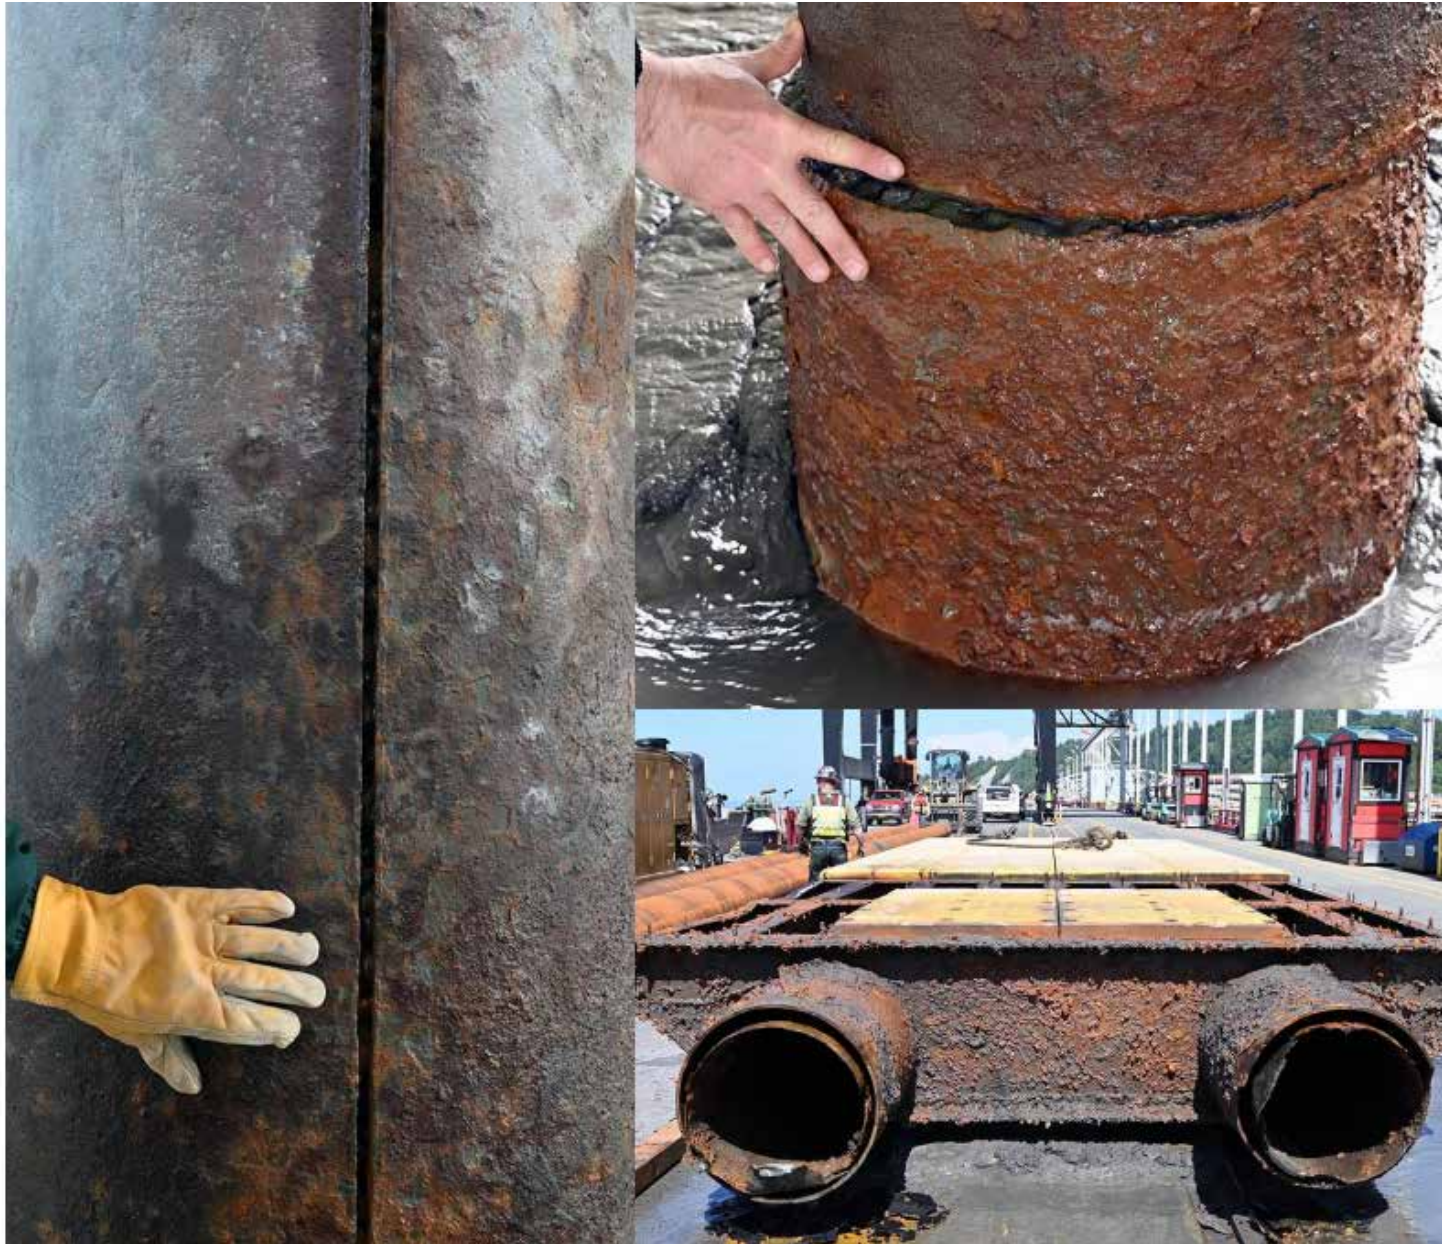
Photographs taken during 2020 Underwater Pile Inspections

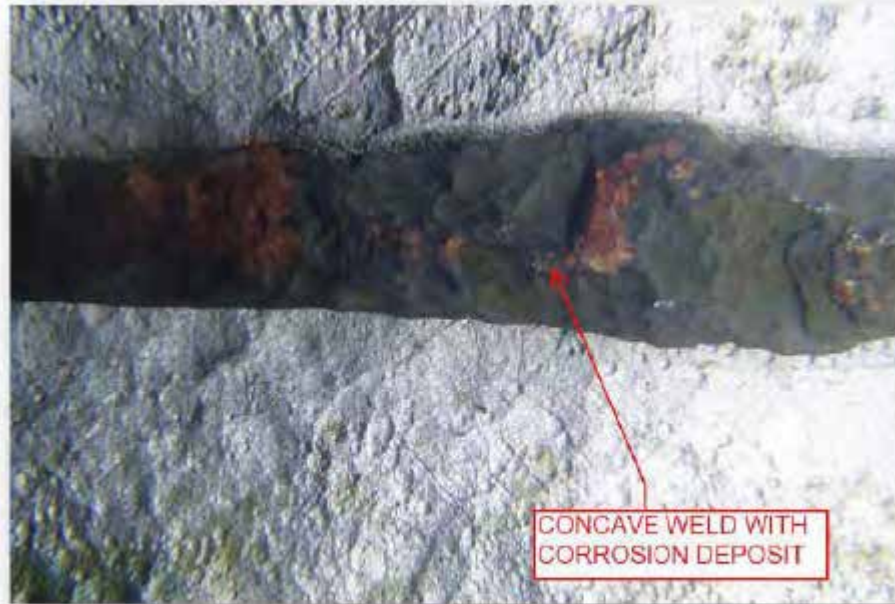
CONCAVE WELD WITH
CORROSION DEPOSIT

Typical Field/Pile Splice Weld Corrosion (Terminal 1 Pile 47U)

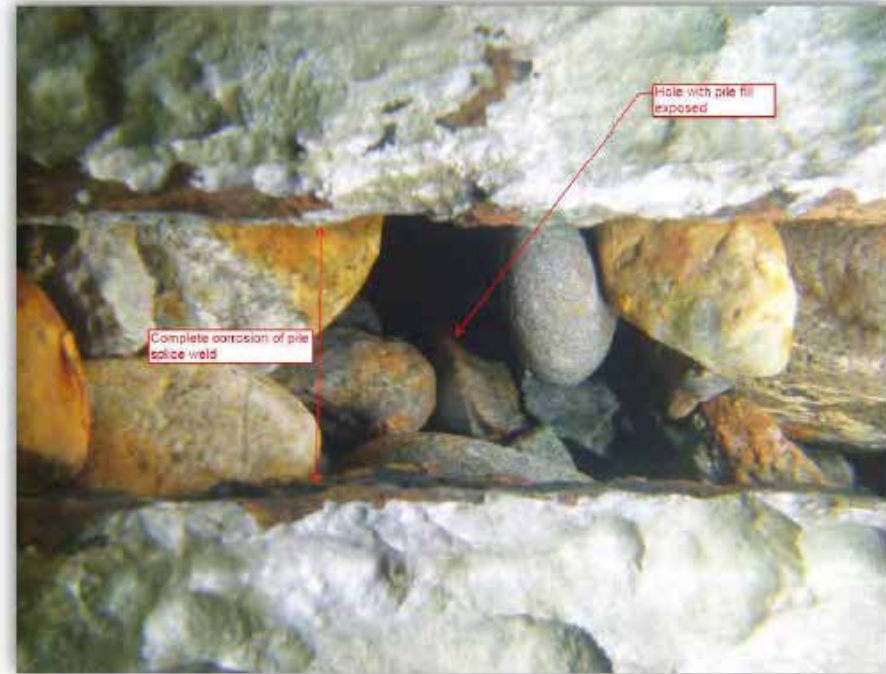
Complete corrosion of pile
splice weld

Hole with pile fill
exposed

Black water camera image of Pile 47.75V. Note complete
corrosion of weld

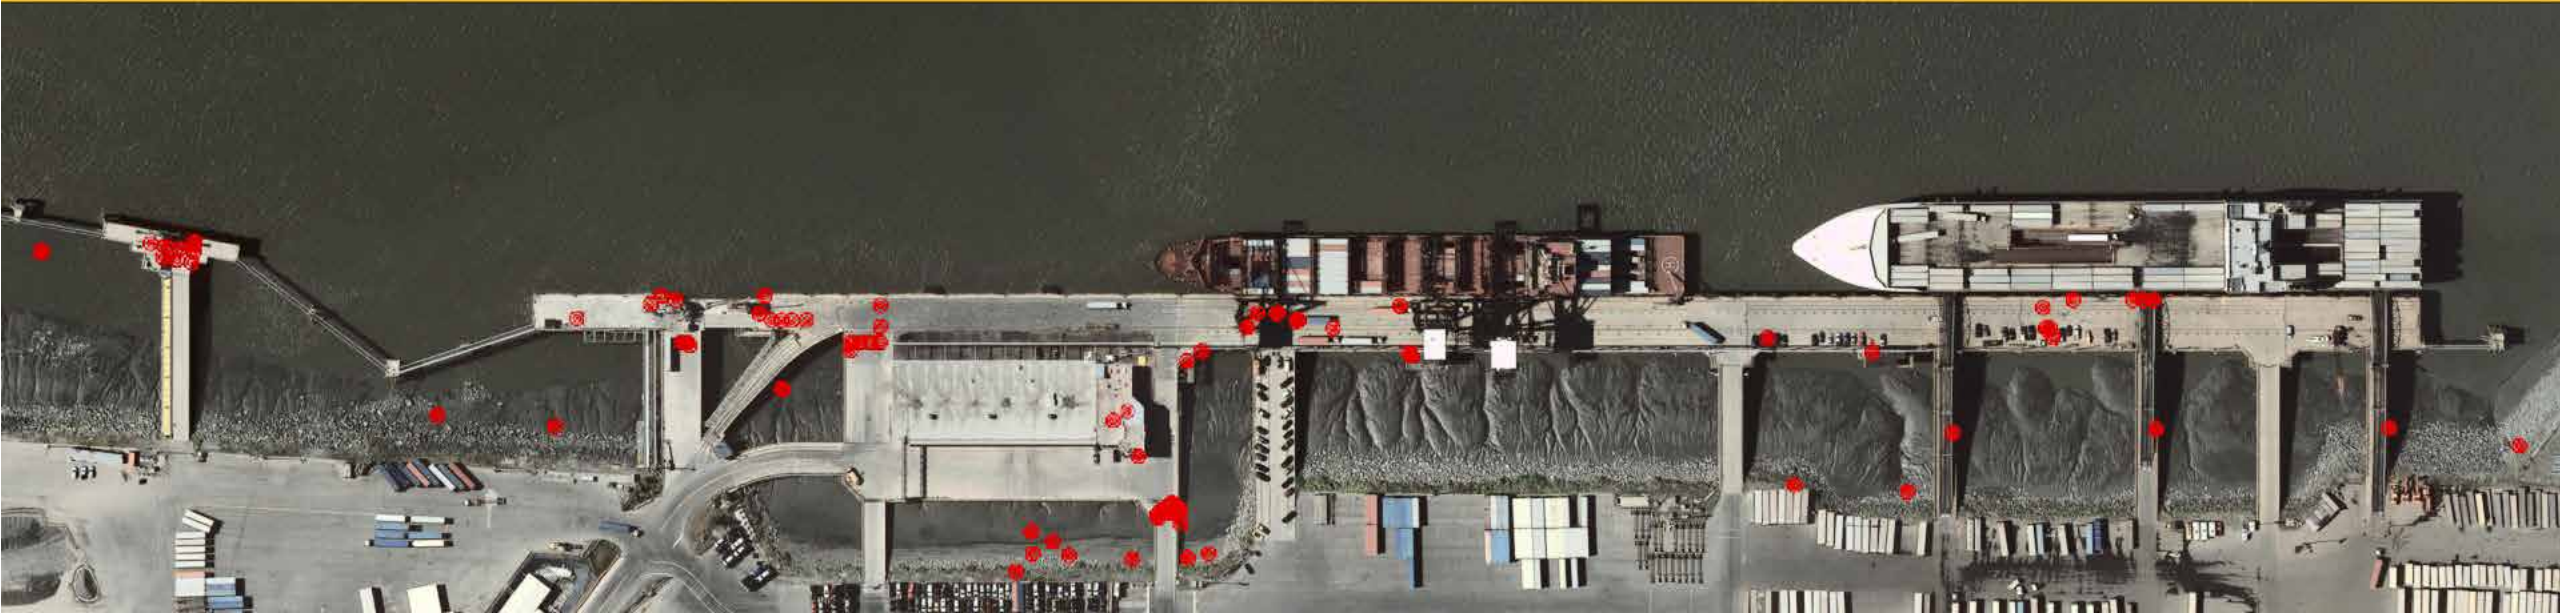
Case Study - Port of Alaska

POL2 pile
damage
discovered
spring 2019

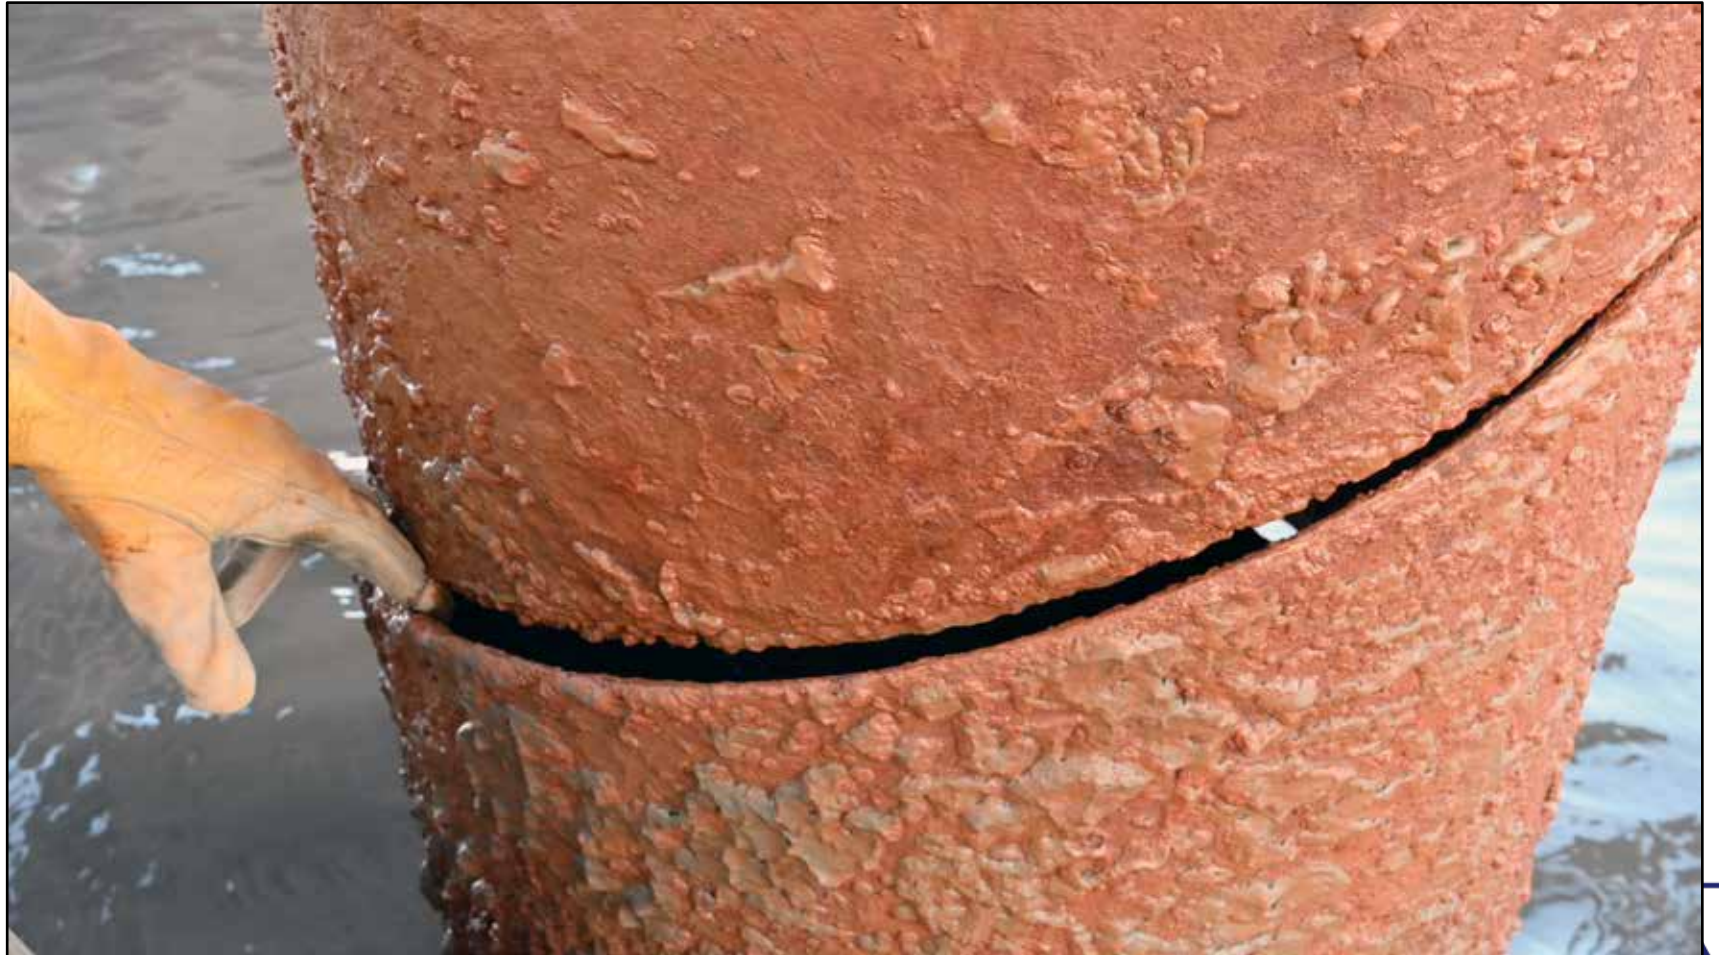
Case Study - Port of Alaska

T1 pile damage
discovered
spring 2019

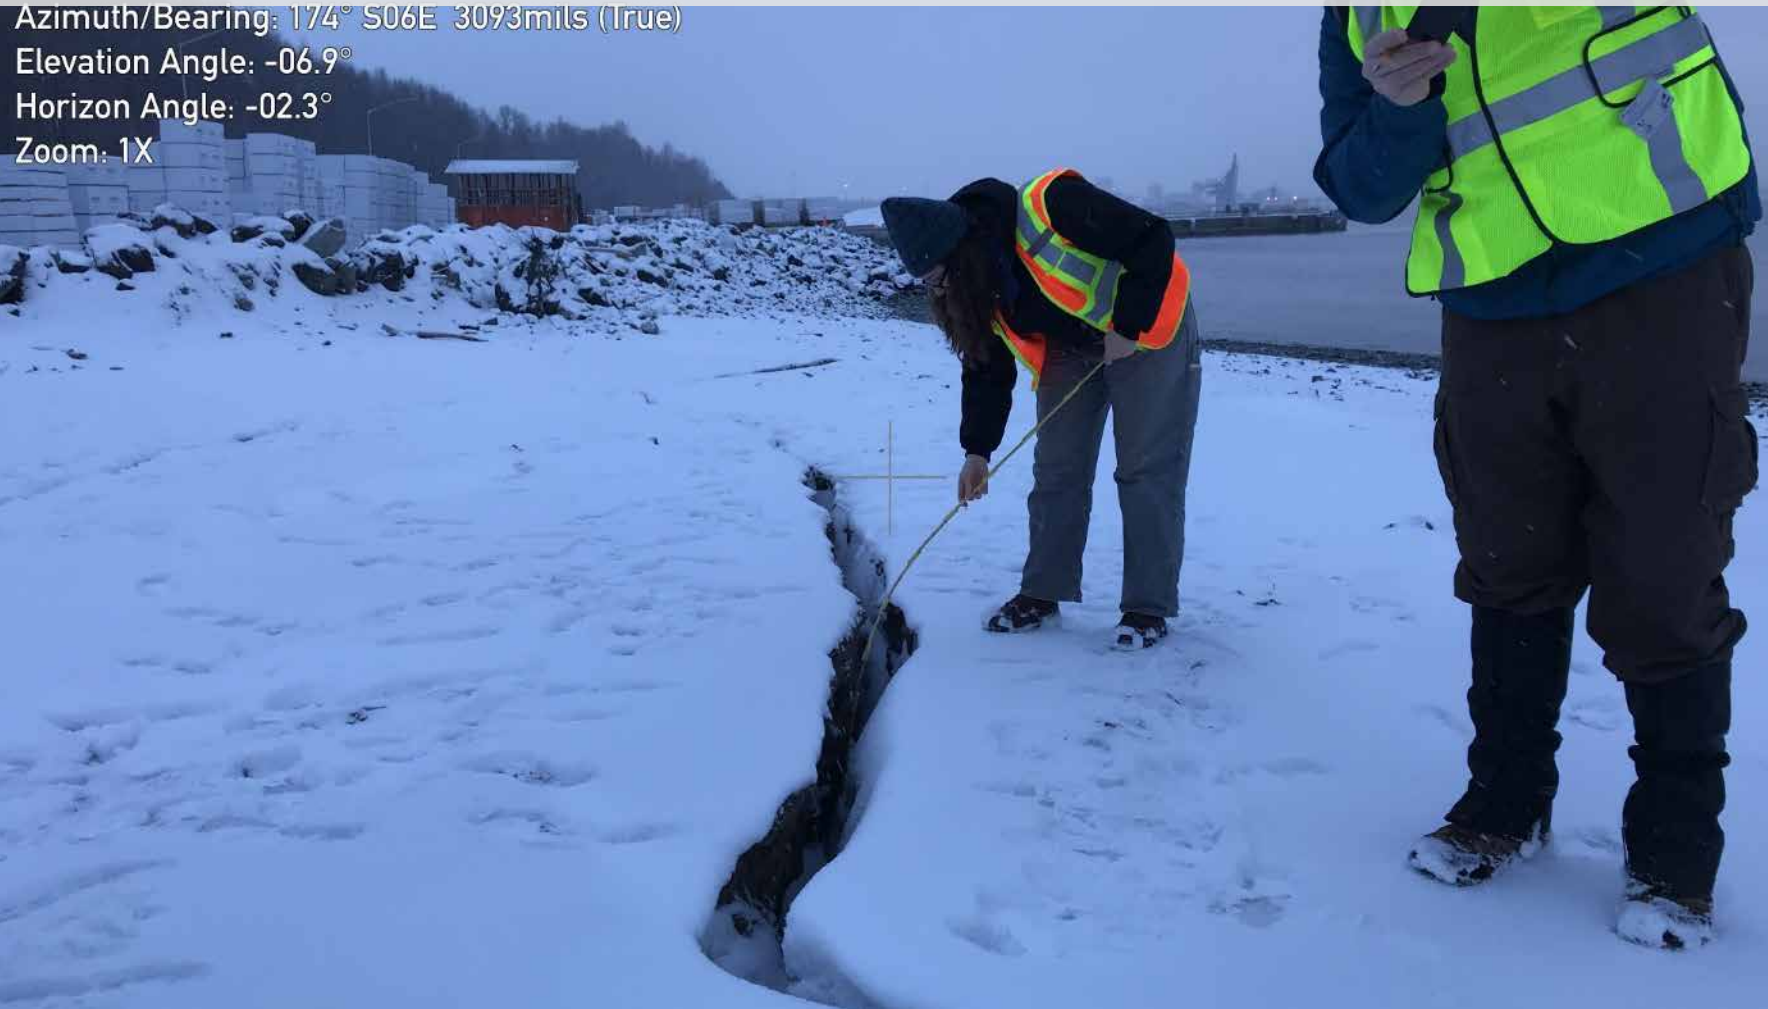
Sand Boils Port of Alaska 2018 Anchorage, M 7.1

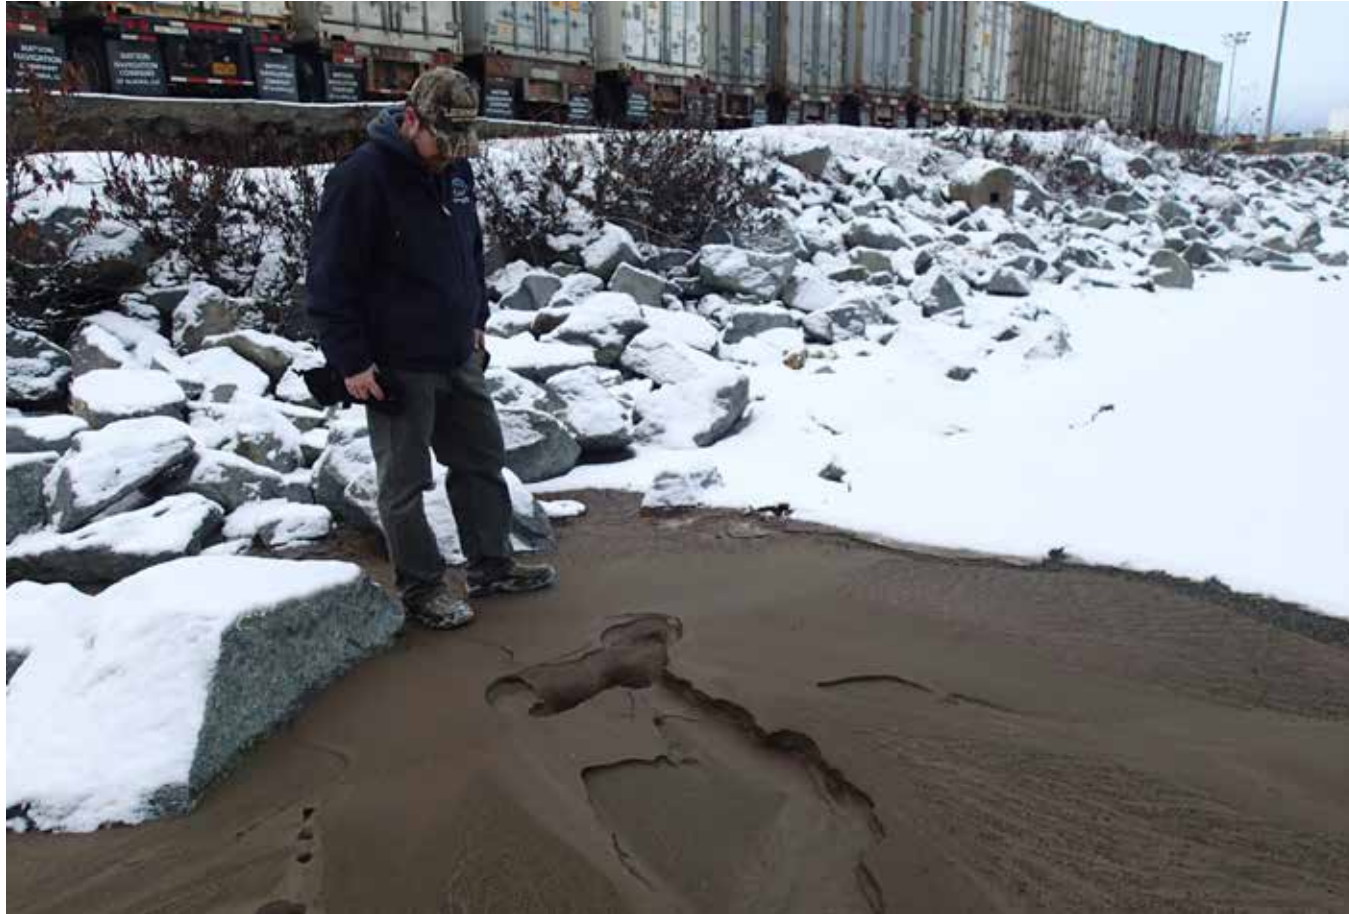
Sand Boils Port of Alaska 2018 Anchorage, M 7.1

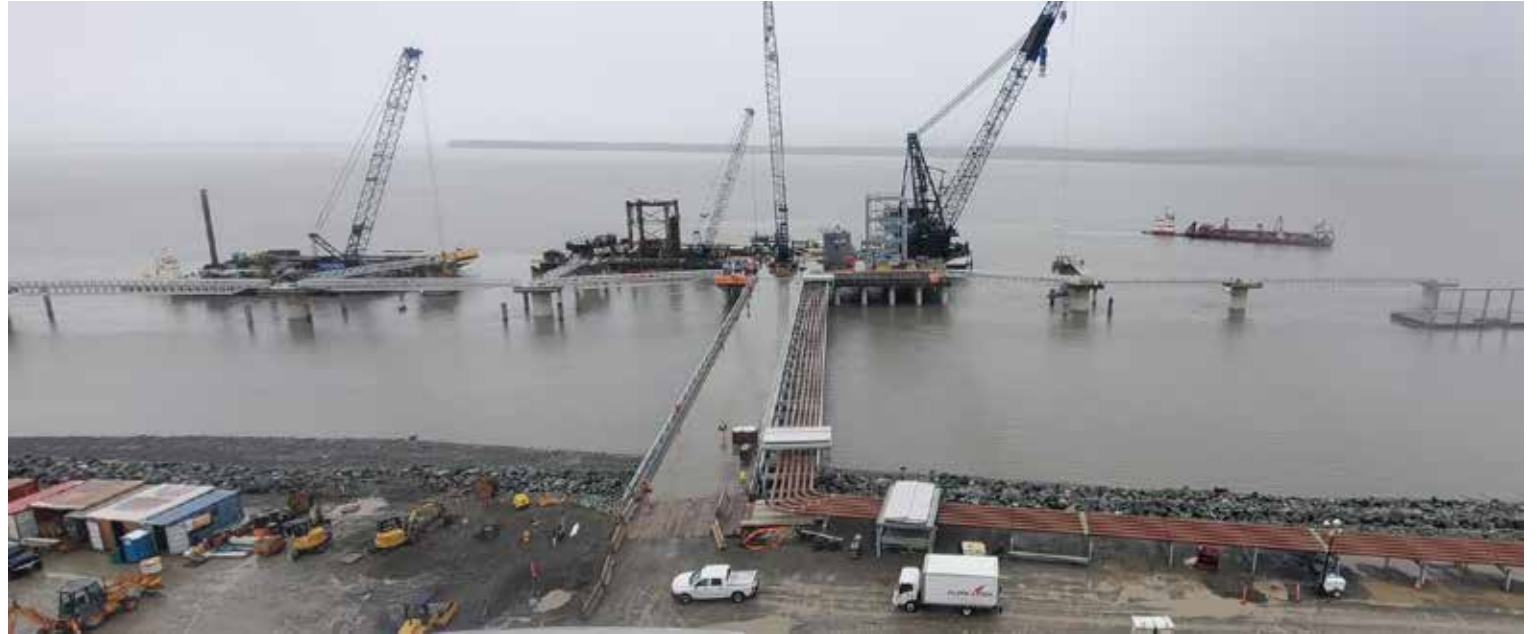
PCT Fact Sheet

- Four primary contracts from 2018 to 2022
- Total cost approximately \$220 million
- 140,000 manhours in 2021 alone
- 71 48-in-diameter piles, 180 feet long
- 9 12-ft-diameter monopiles
- Prime contractor for dock construction: Pacific Pile & Marine

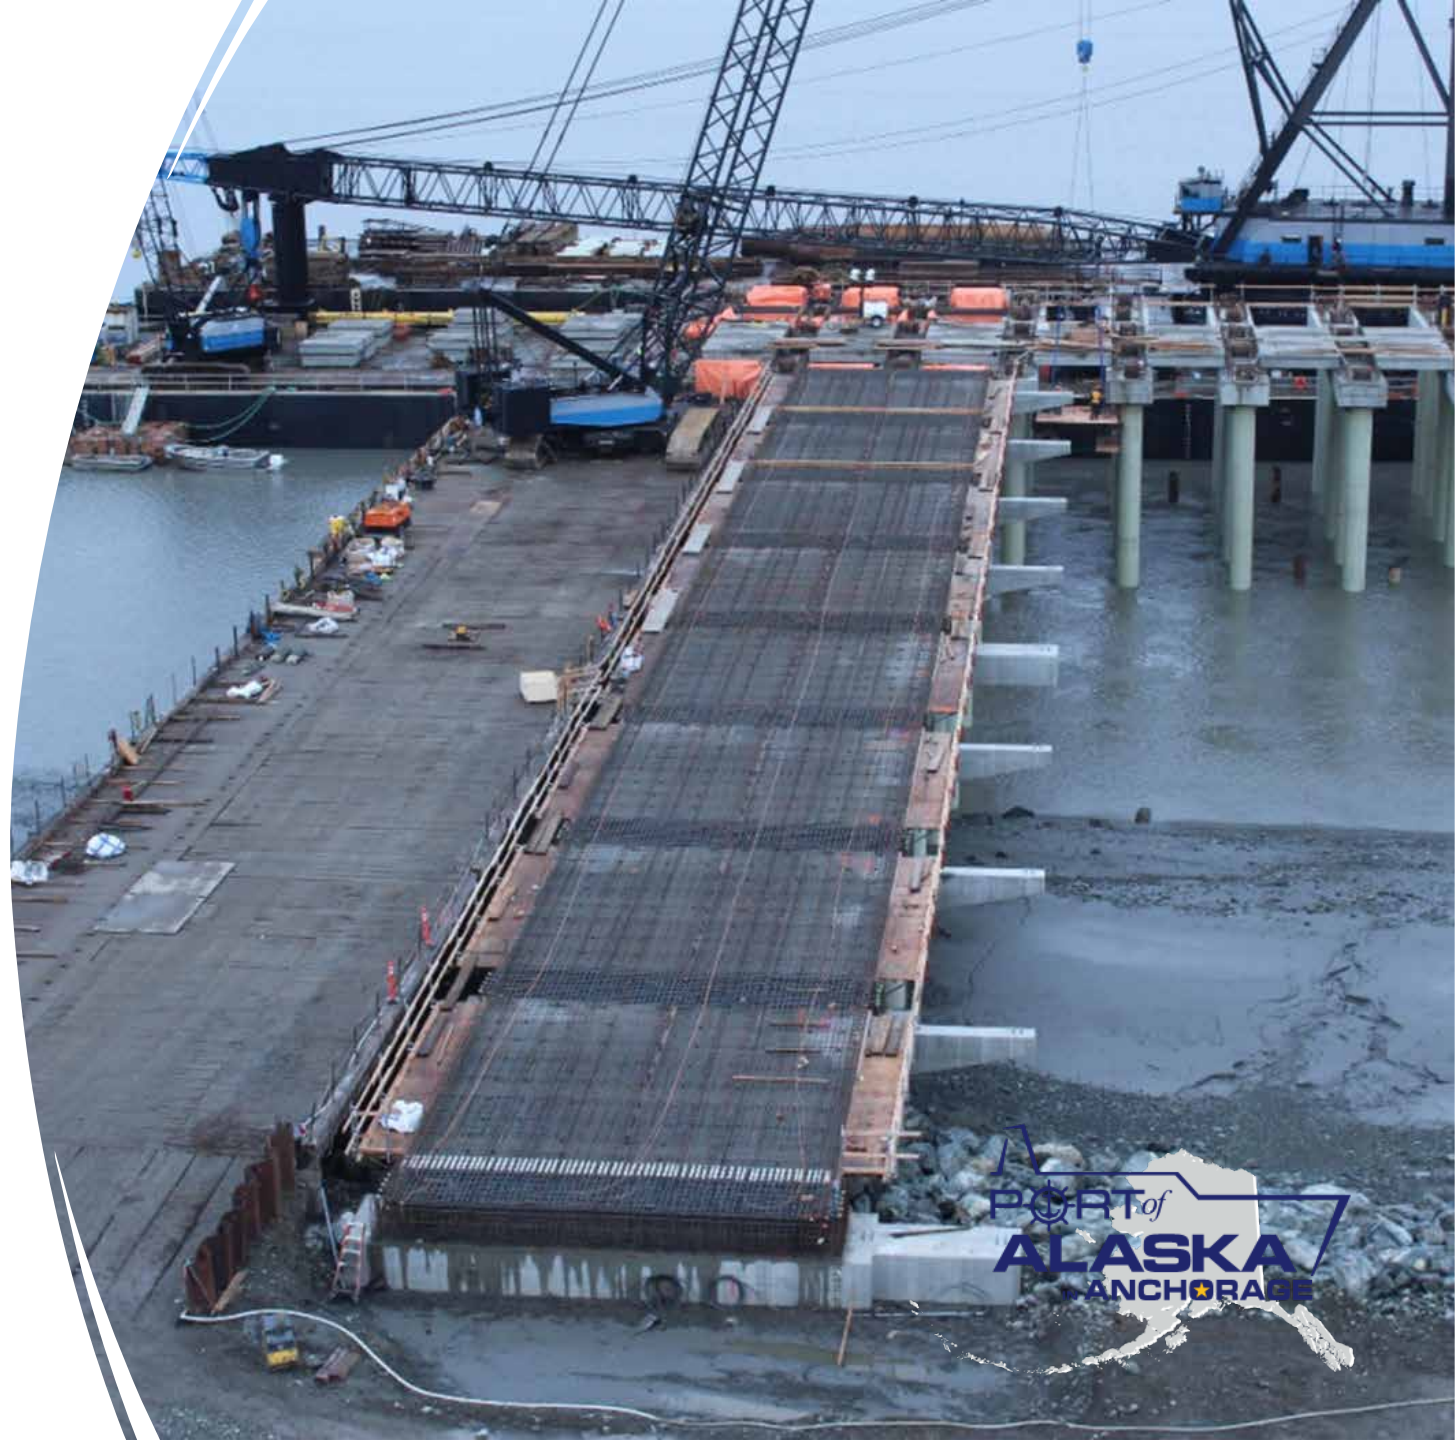
PCT Fact Sheet

- Modern seismic design exceeding national standards
- Ice resistant coatings
- Cathodic protection system

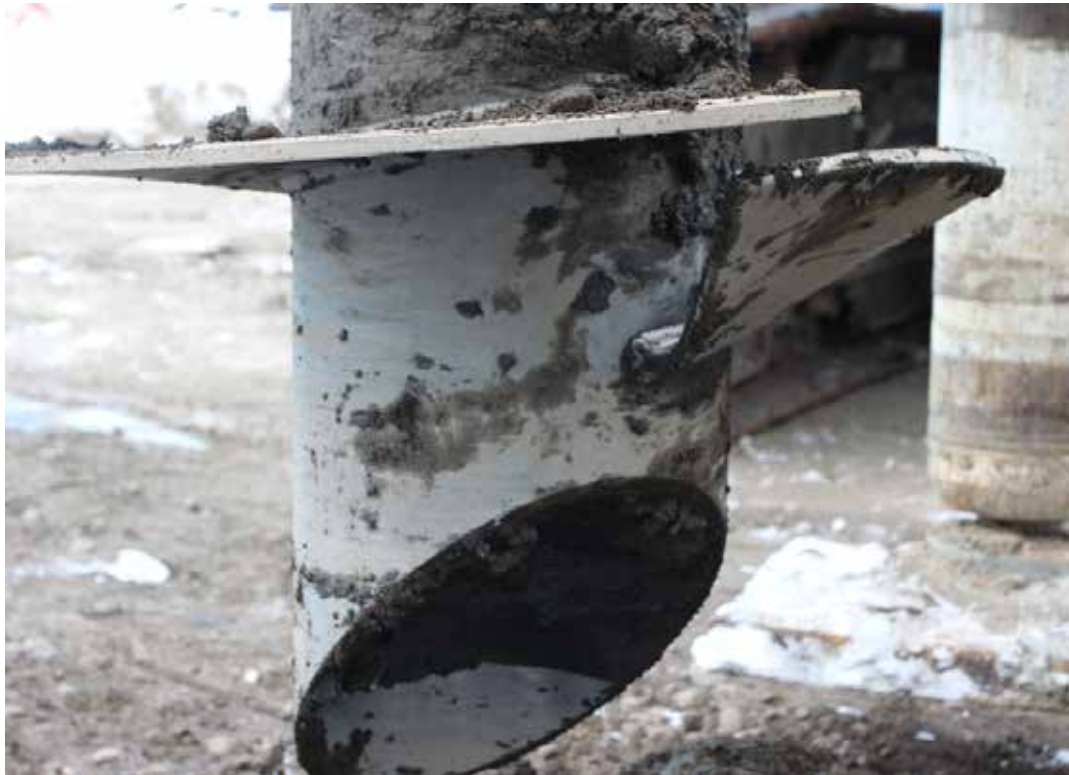
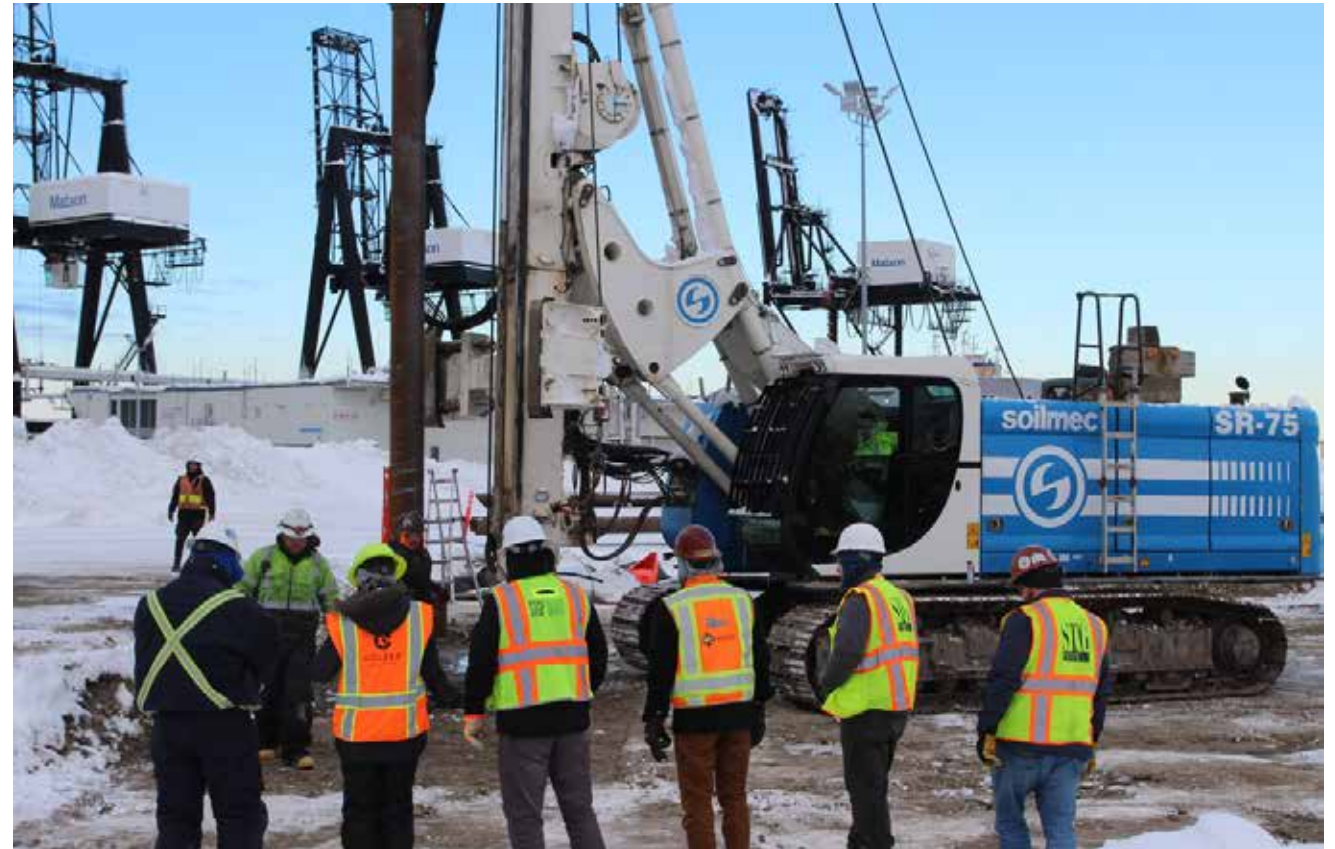
Helical pile damaged by debris.

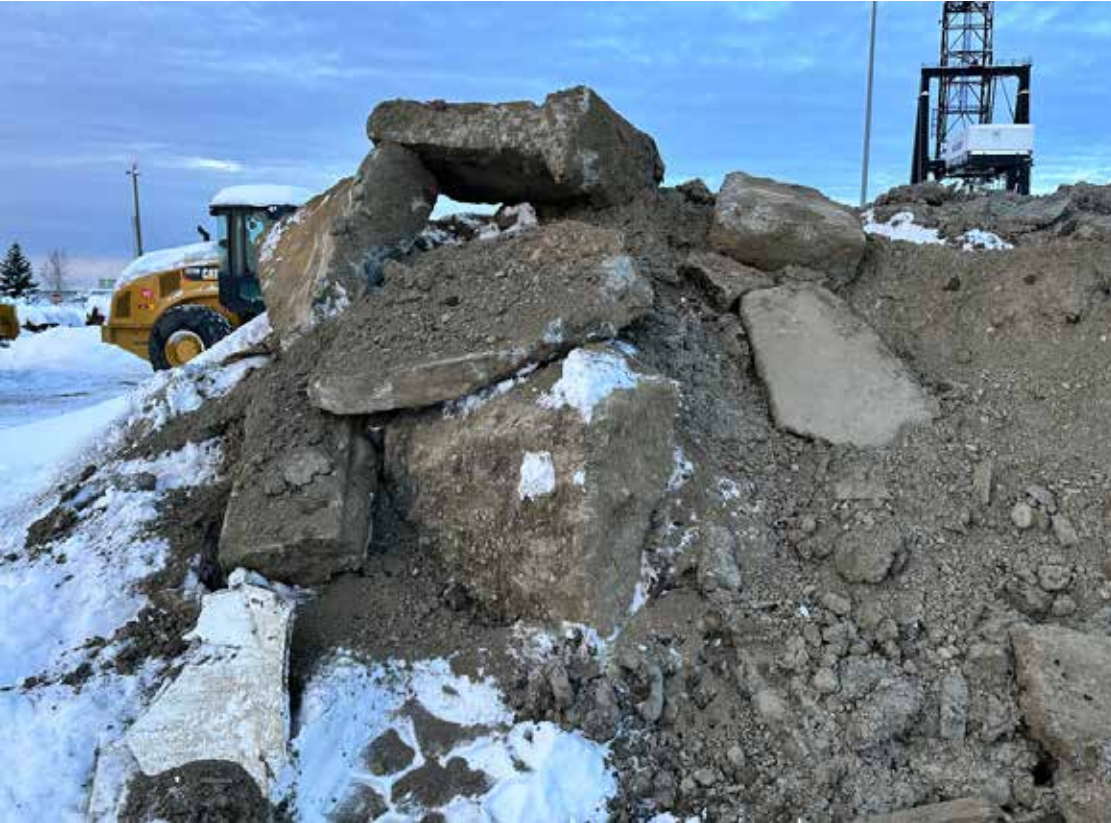
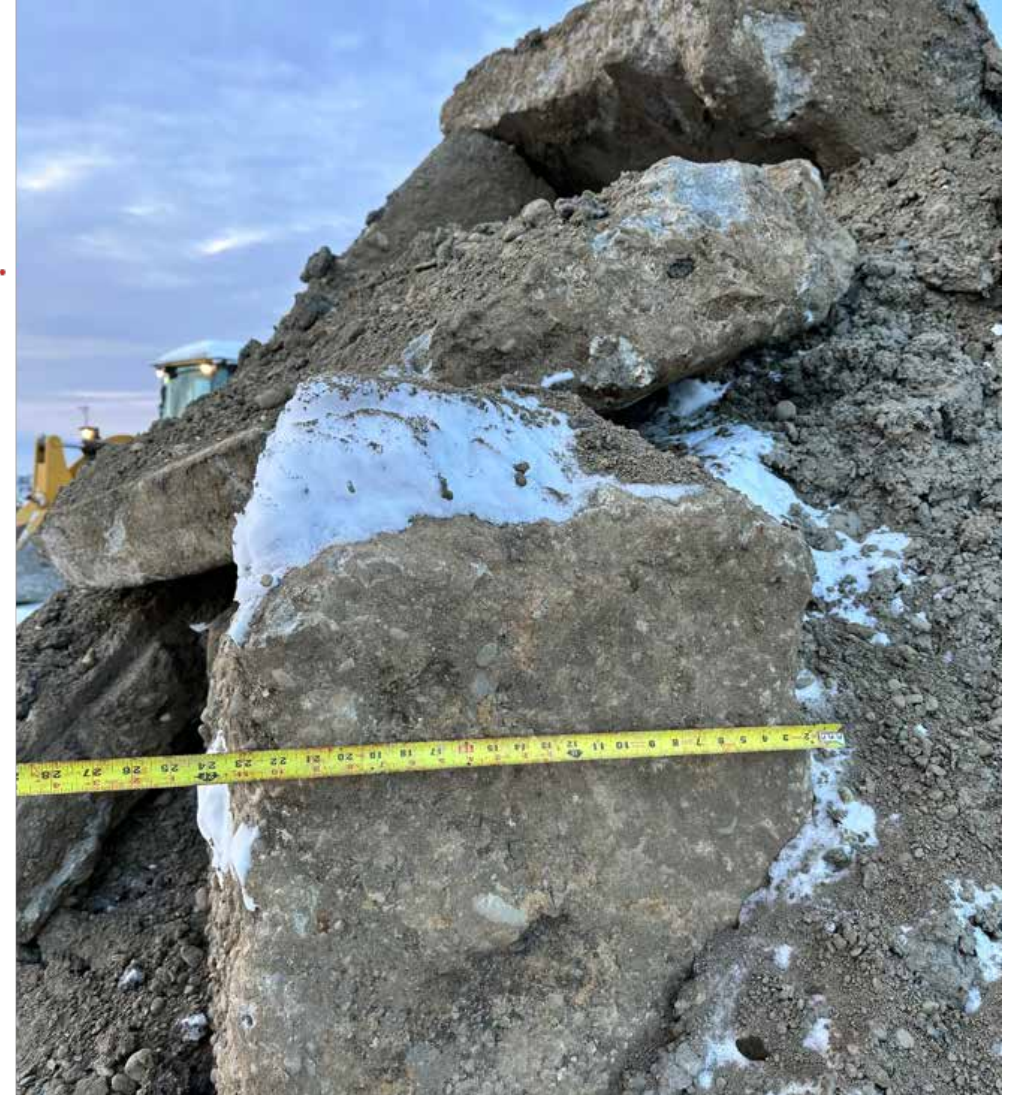
Concrete debris at the Admin Building site

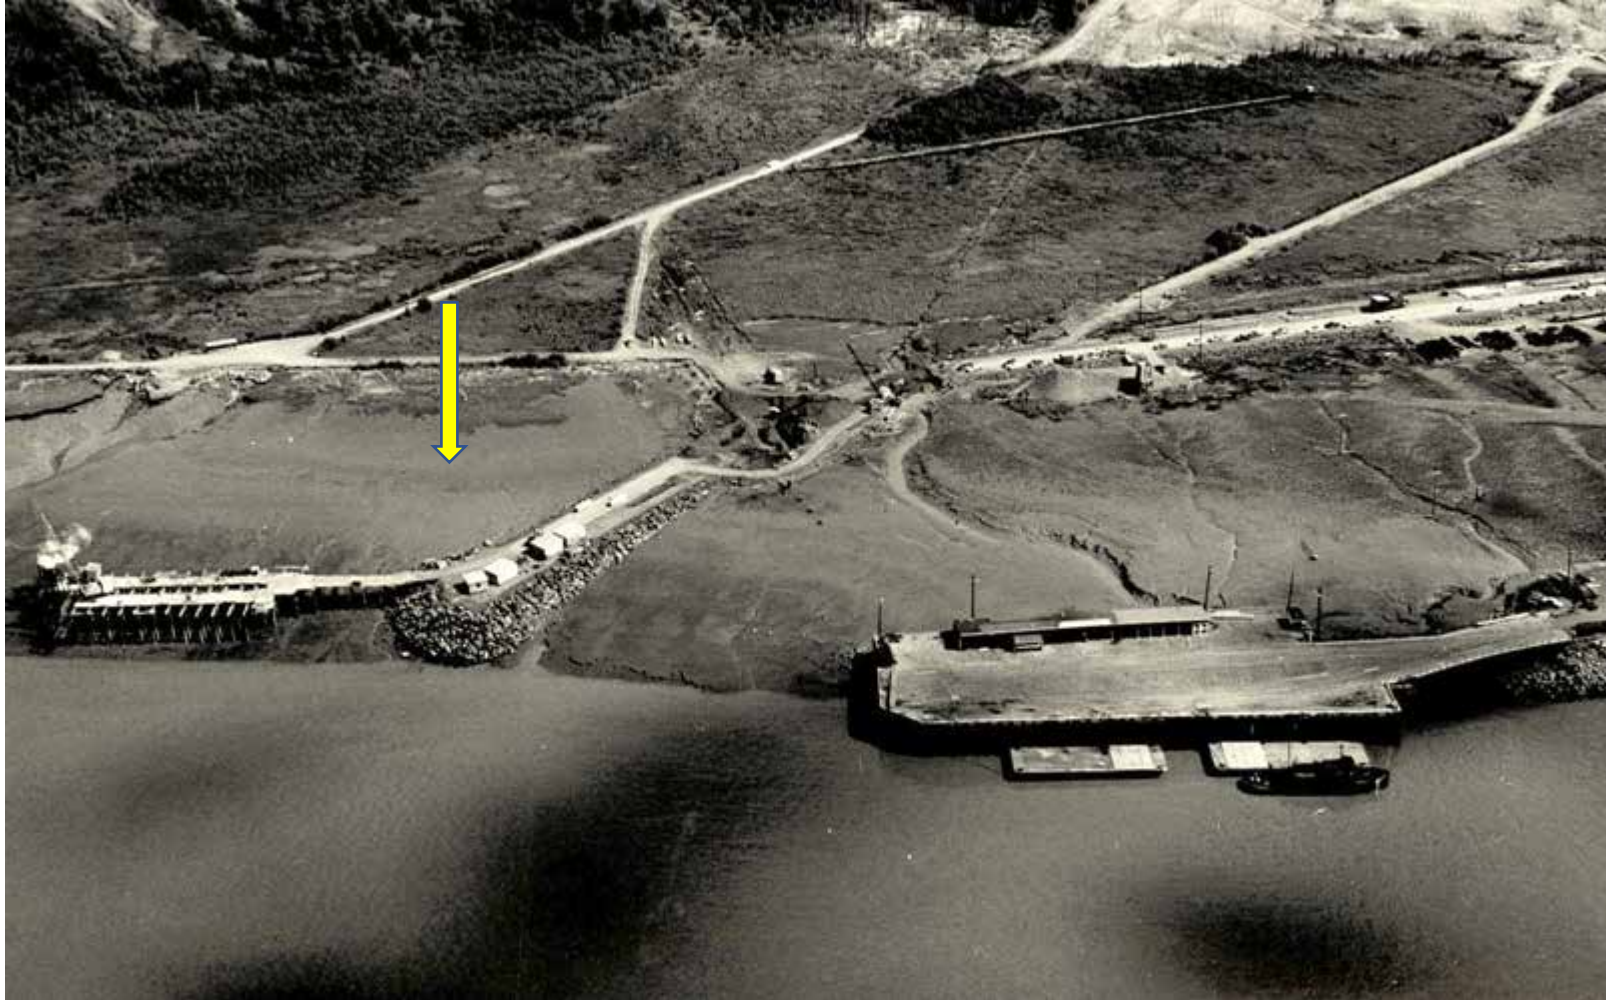
Admin Building site 1959 – No Fill

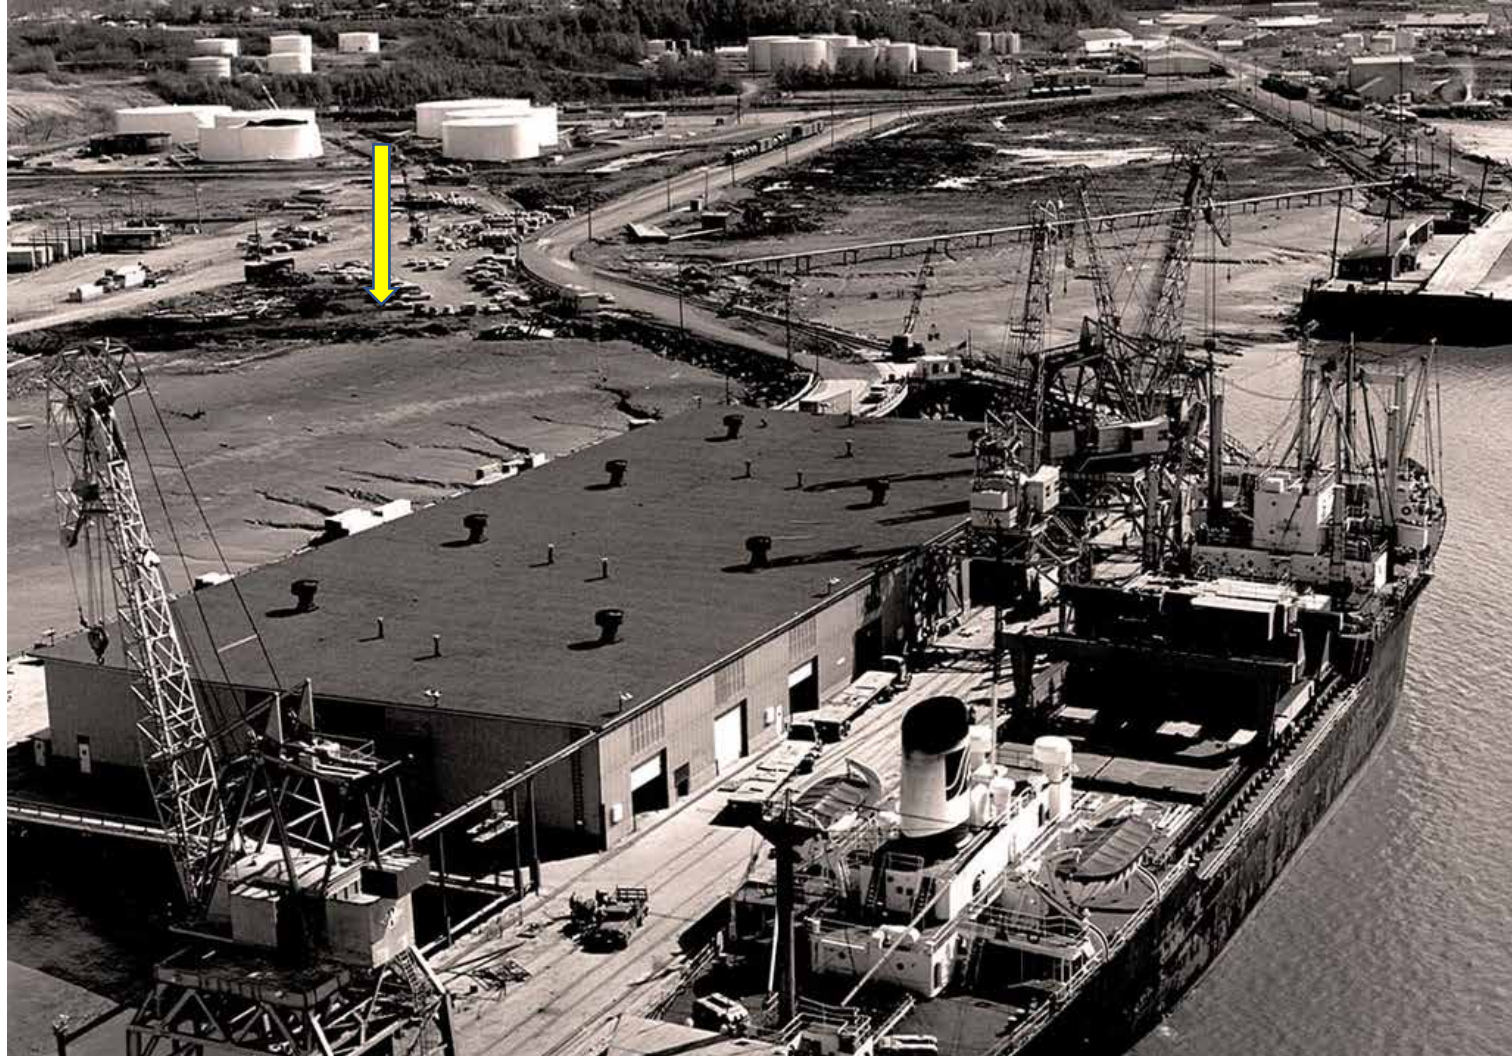
Admin Building site 1964 – Partial Fill

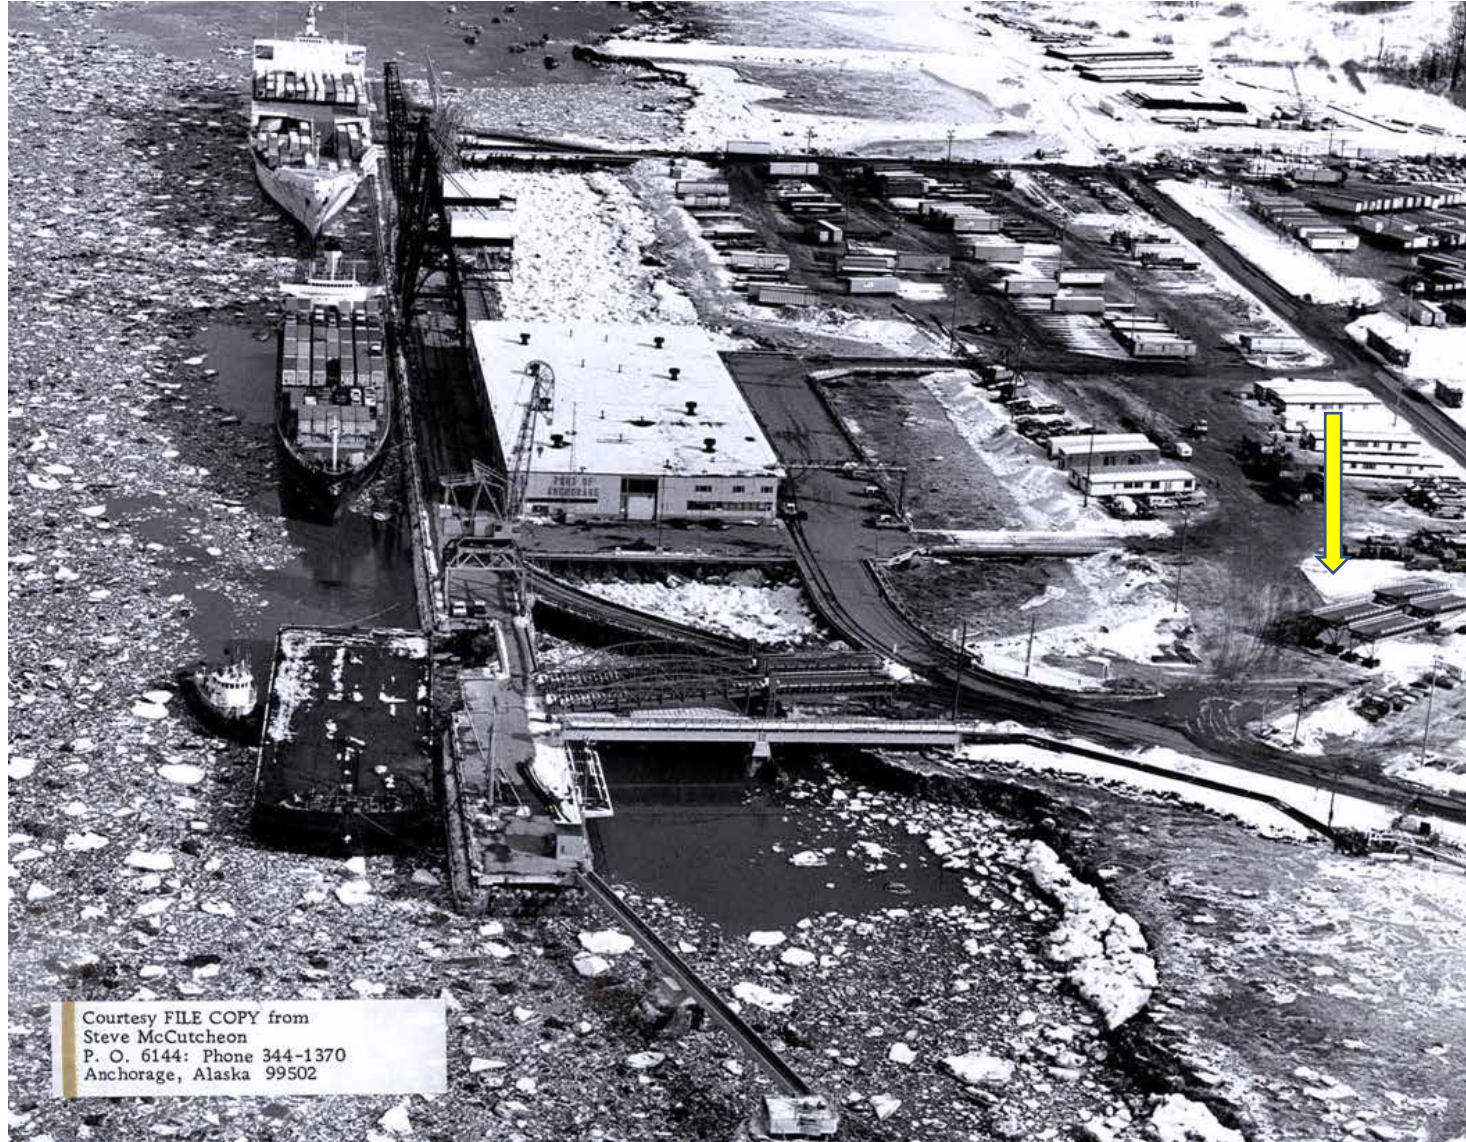
Admin Building site late 1960s – Filled

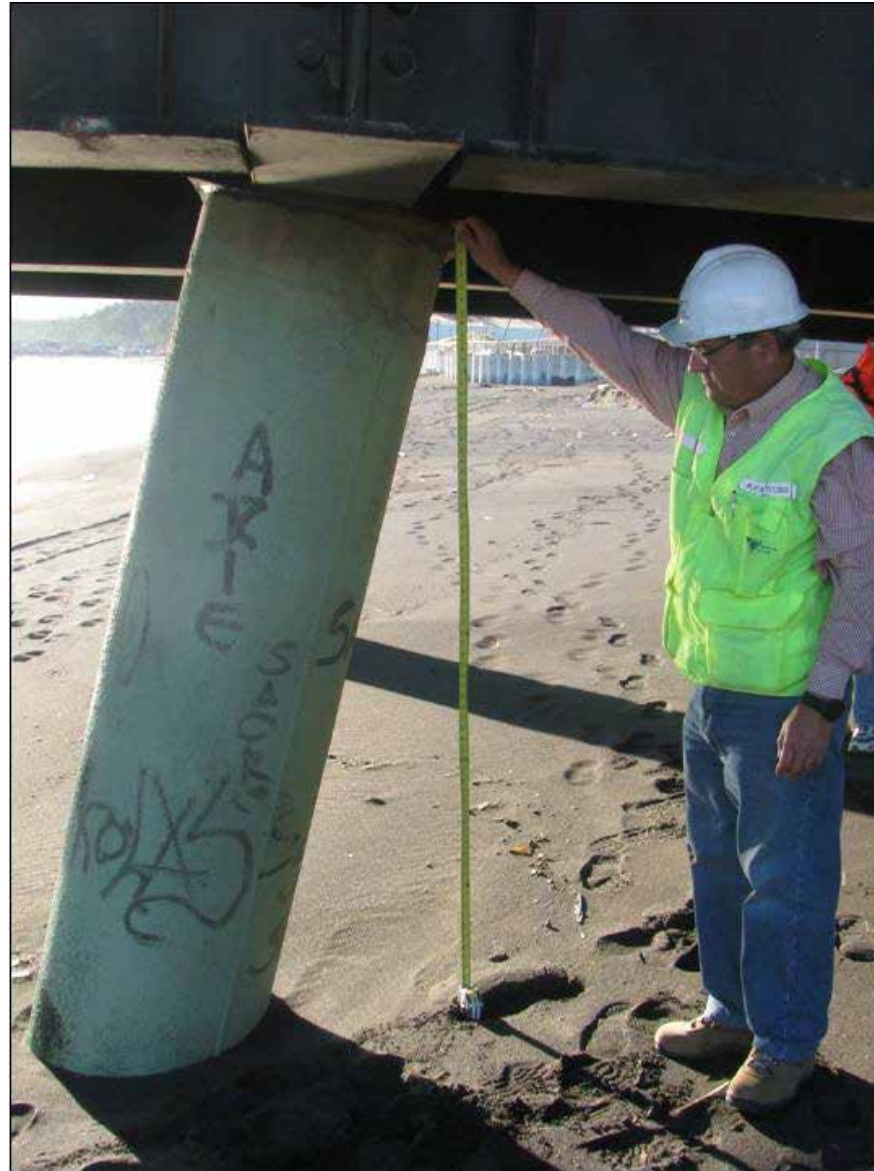
Kinematic Loads

§ Moving soil

§ (2010 Chile event)
