APP Conference

John Daley PE PAMP Engineering Manager

Port of Alaska - Anchorage

Port of Alaska Modernization Program

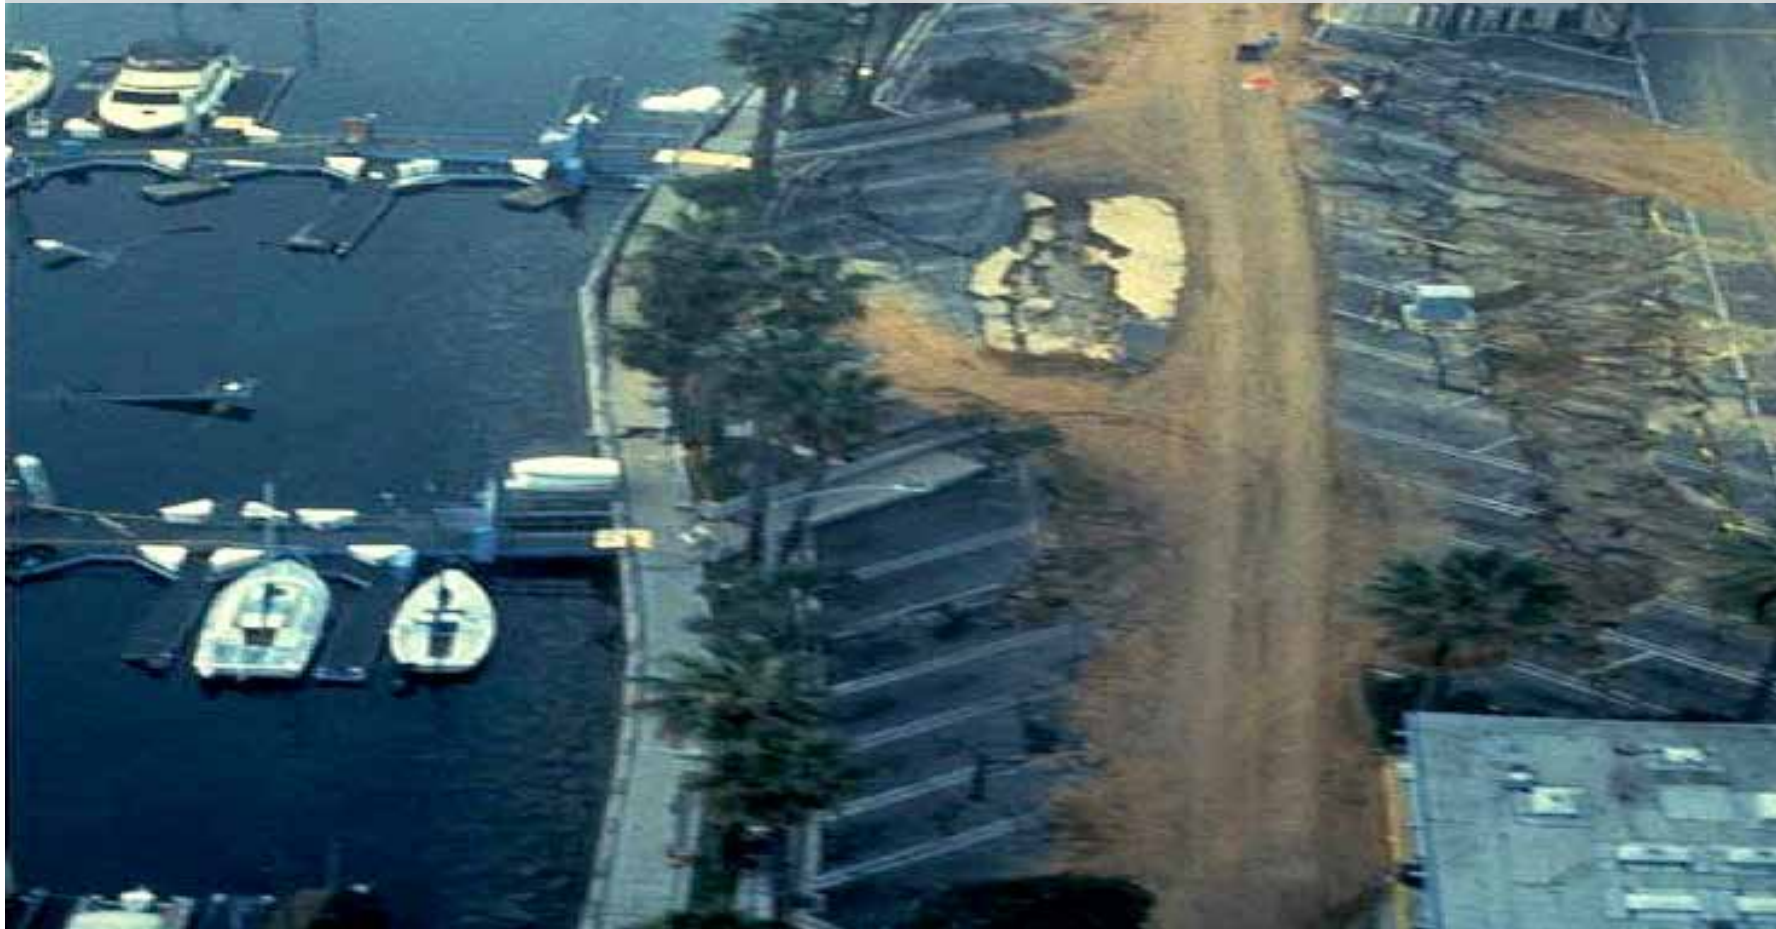
Retaining Wall Failure
Kings Harbor Marina, Redondo Beach
1994 Northridge, M 6.7

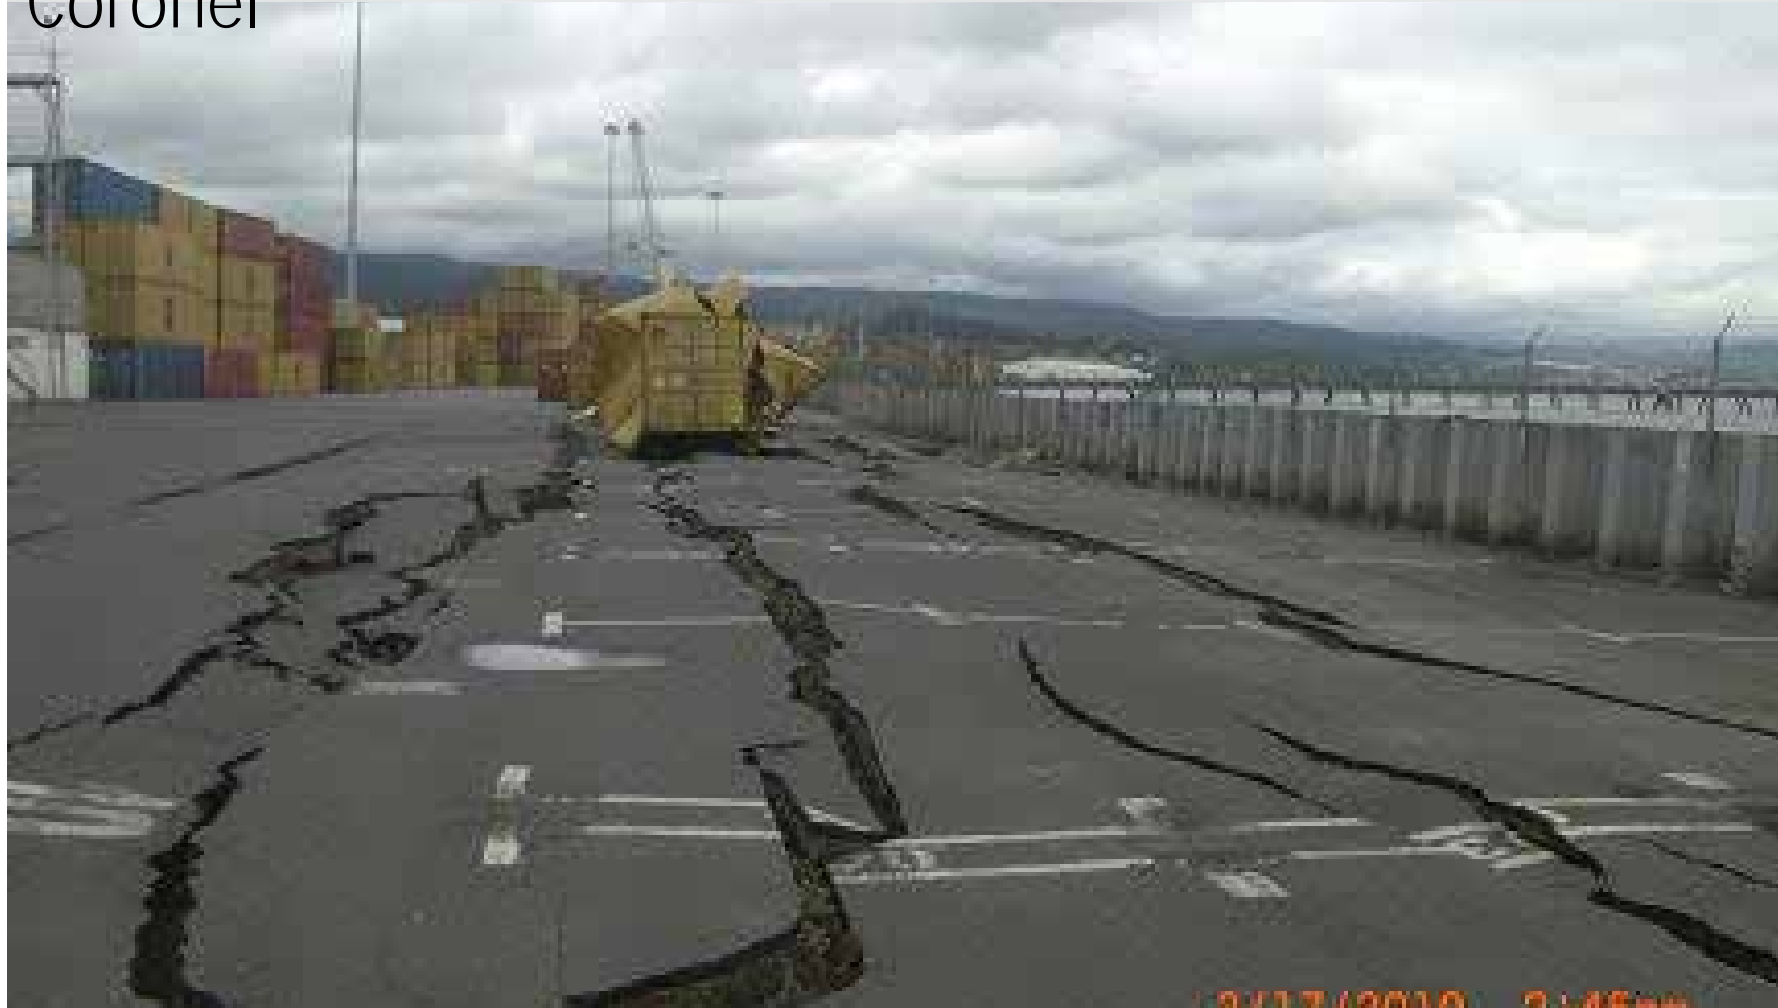
February 2010 Maule, Chile Earthquake Magnitude 8.8 Ground Failure/Lateral Spreading Port of Coronel

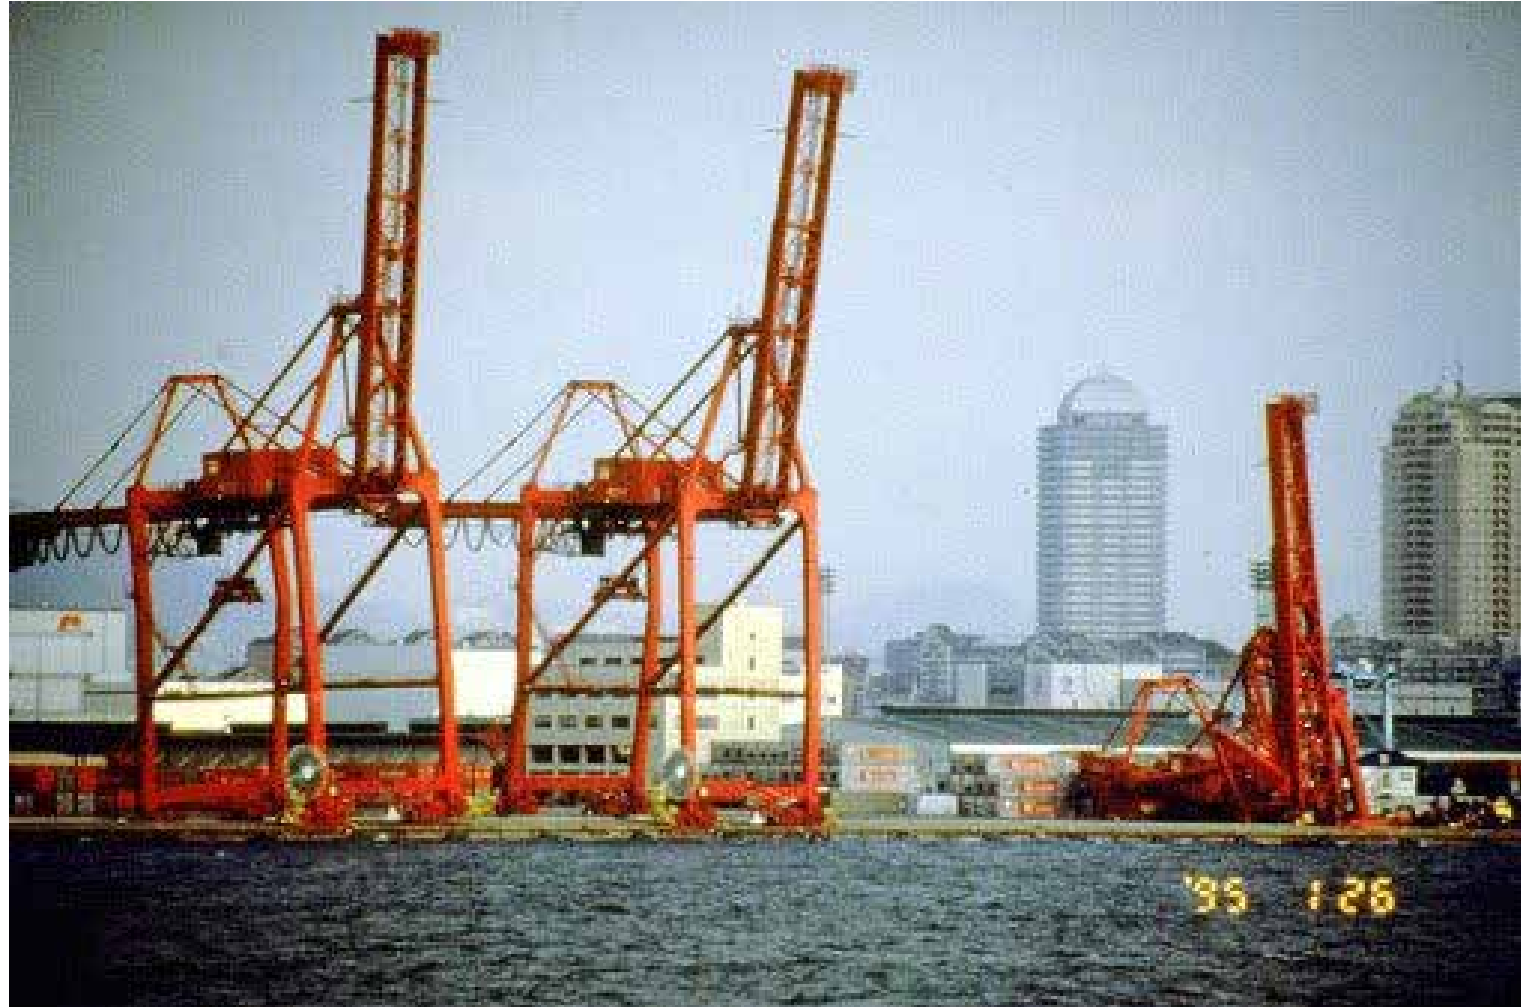
1995 Kobe Japan Mw 6.9

Many large container cranes were damaged on Rokko Island. The damage to the cranes is primarily due to rails spreading and settling. Crane damage consisted of buckling of legs at the portal ties.

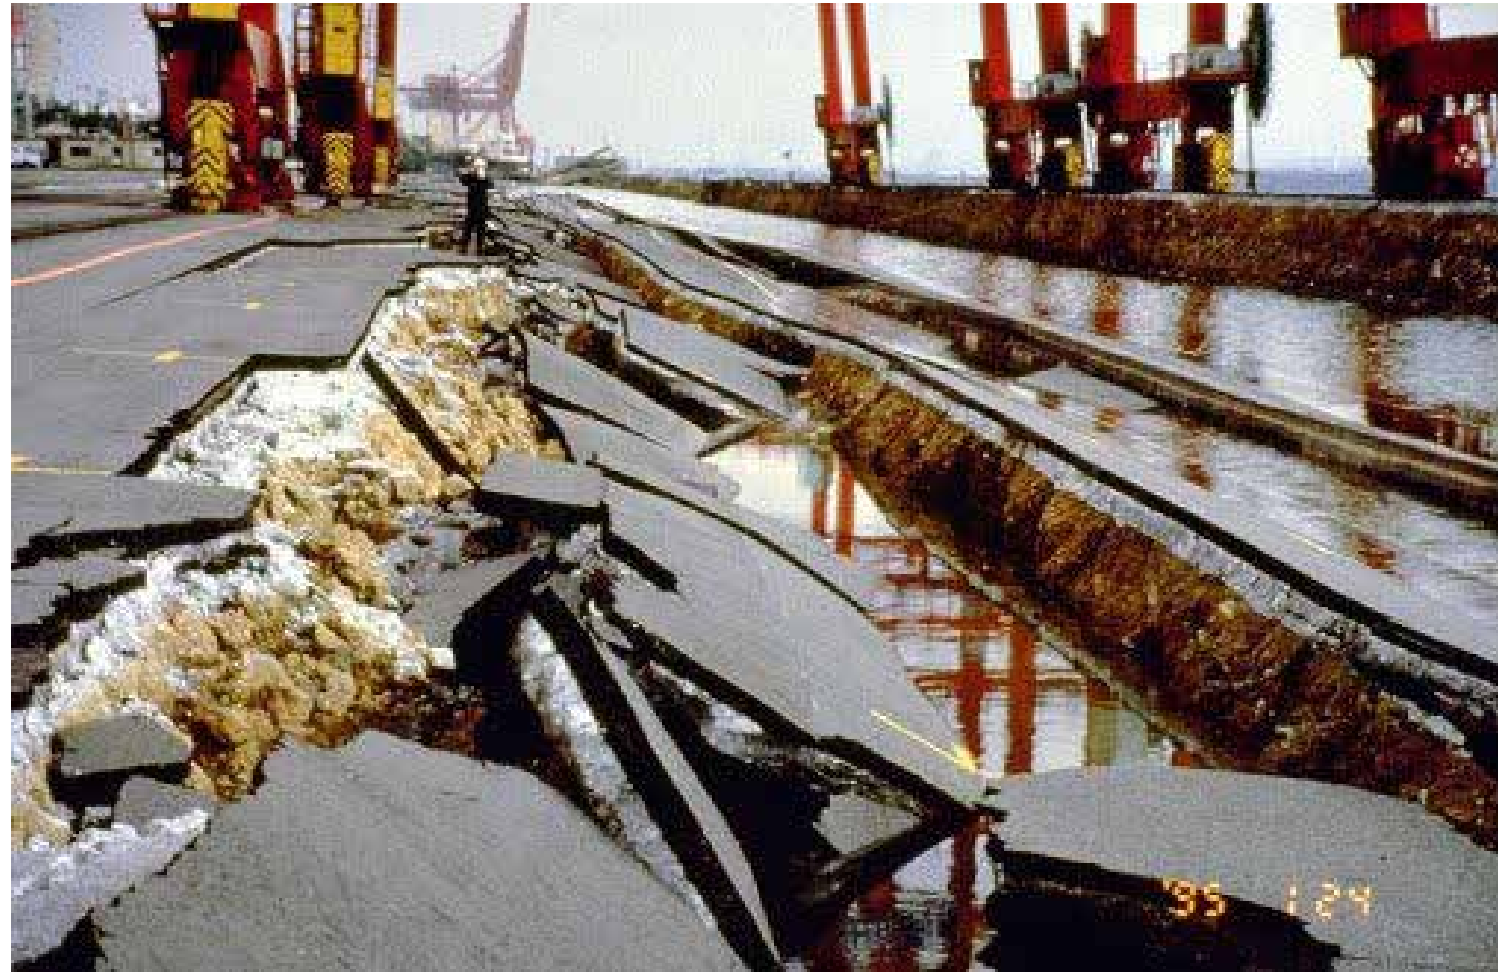
1995 Kobe Japan Mw 6.9
Liquefaction and lateral spreading damaged the crane rails

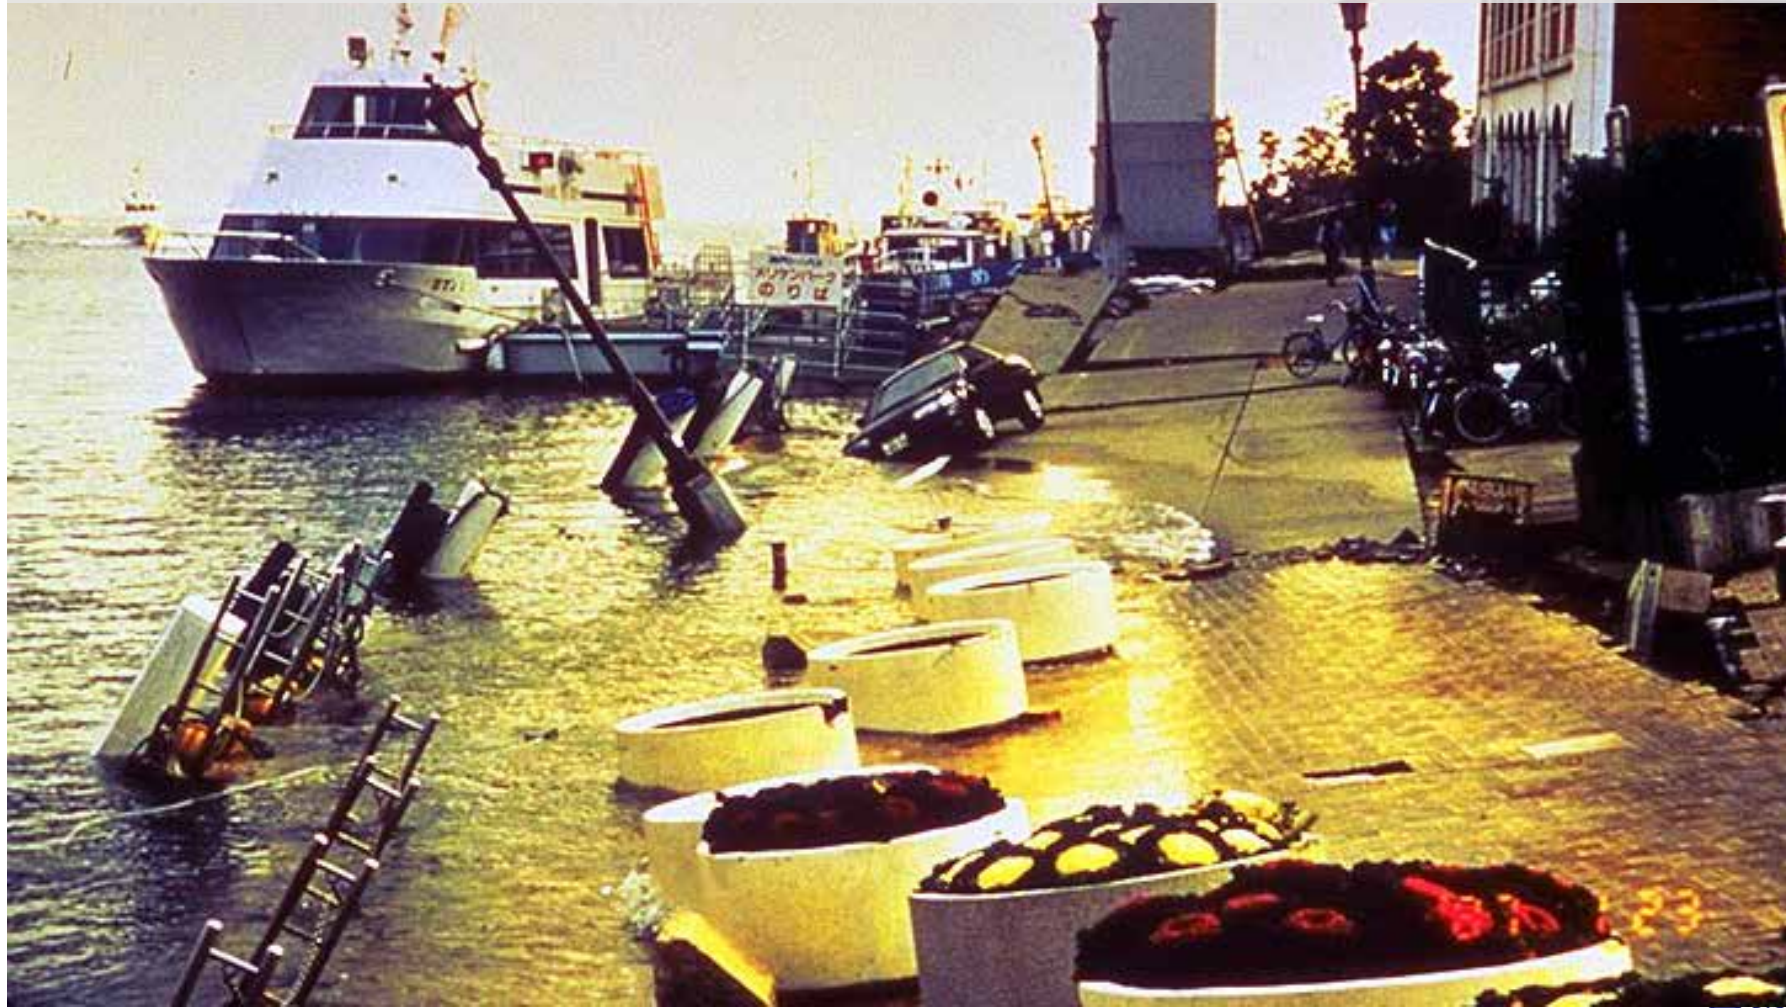
Lateral Spreading – Bulkhead Failure 1995 Magnitude 6.9 Kobe Japan

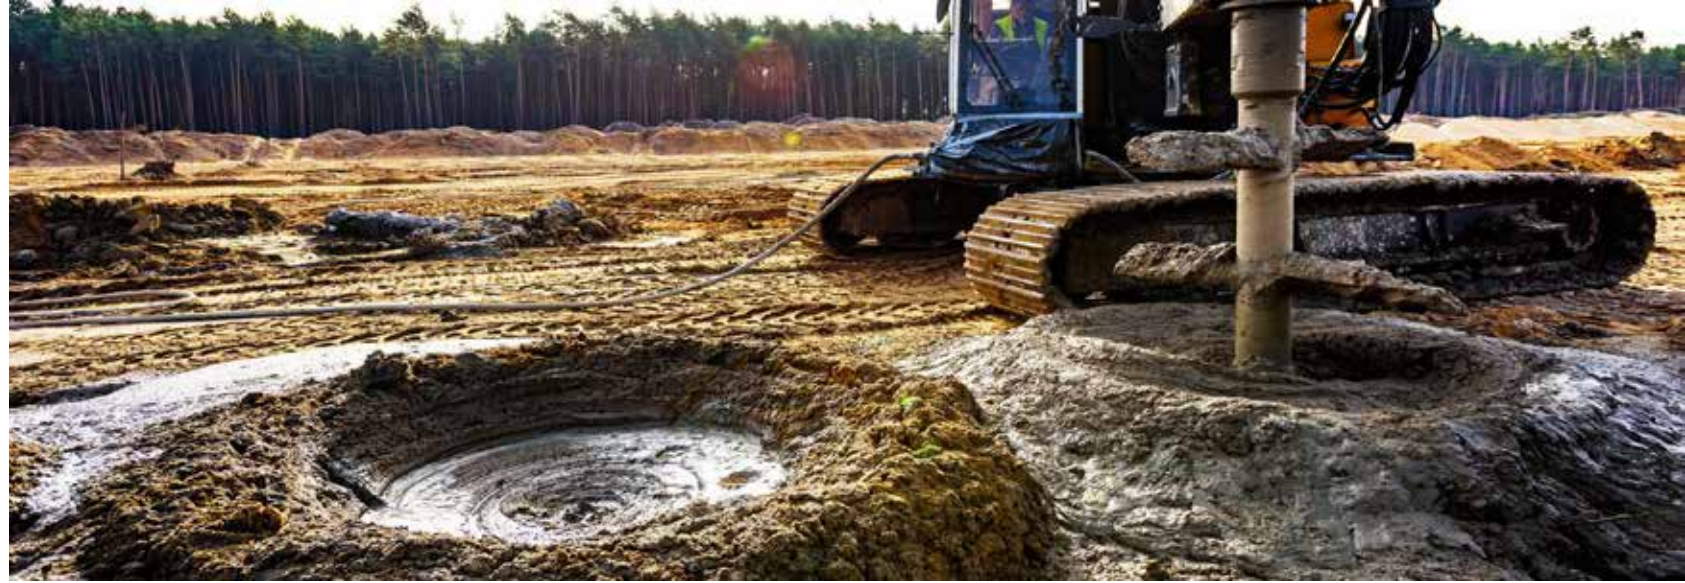
Engineered Slopes - Deep Soil Mixing

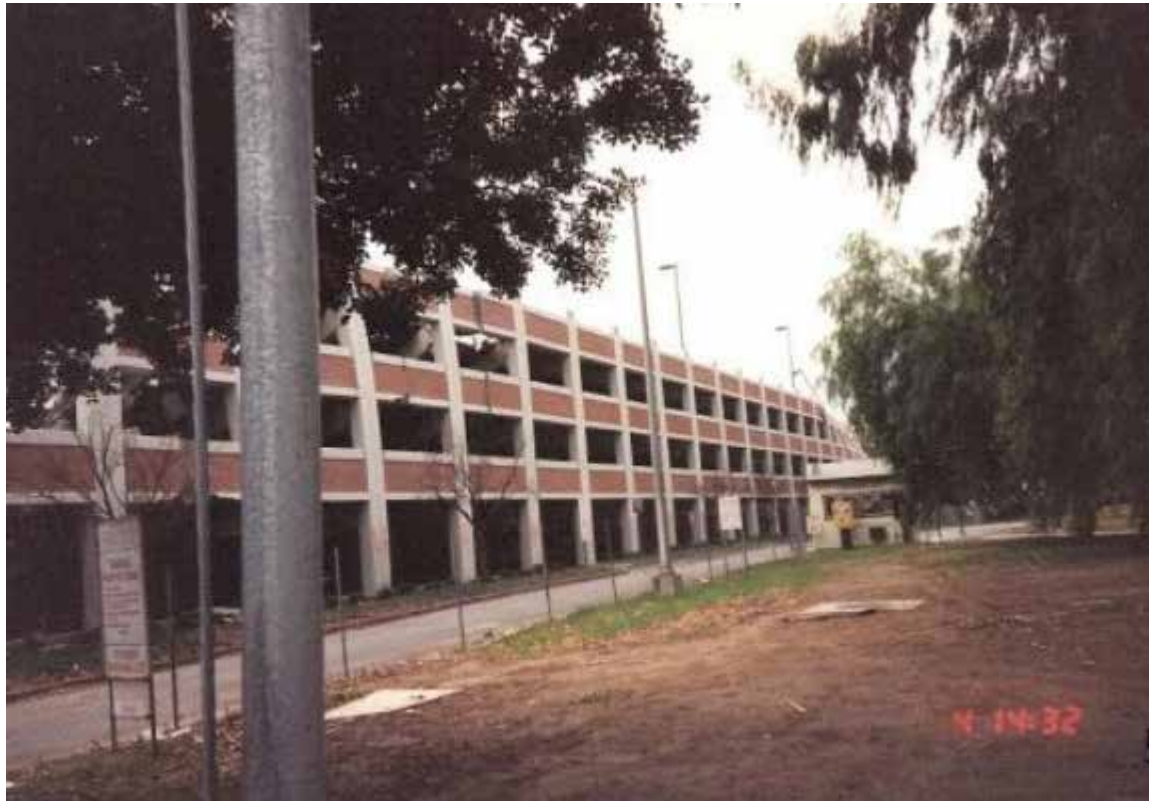
Before

Ductile Concrete (Northridge 1994 Mw 6.7)

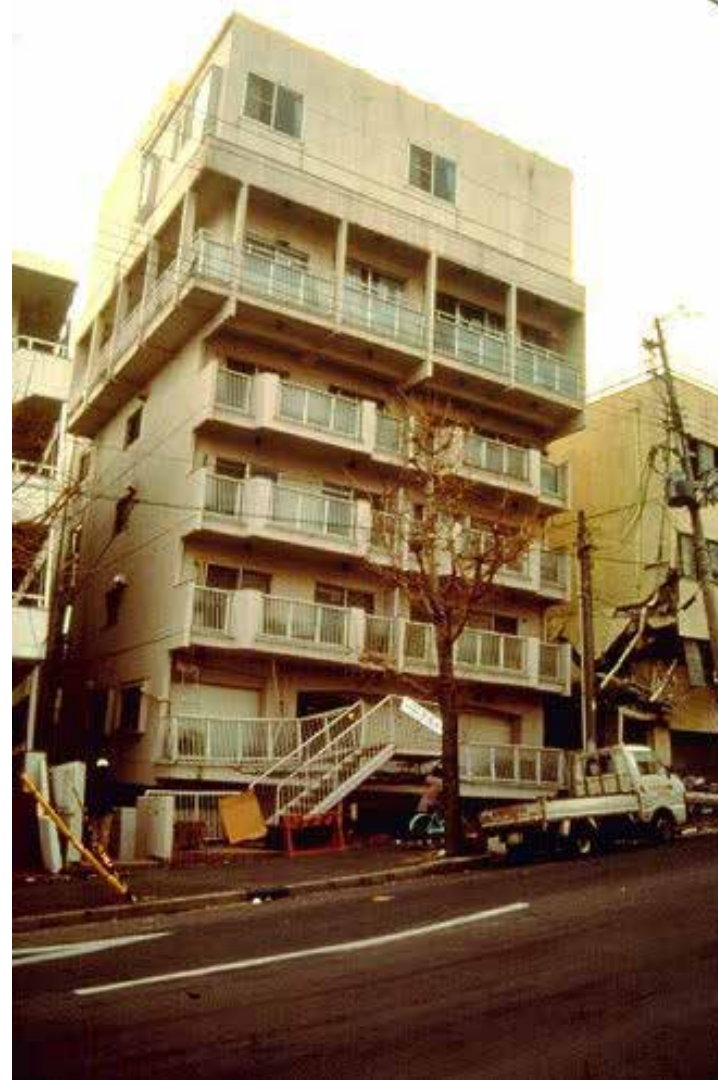
1995 Kobe Japan Mw 6.9

Five-year-old 6-story concrete frame with garage level collapse. This was an exception to the rule of good performance of newer concrete buildings.

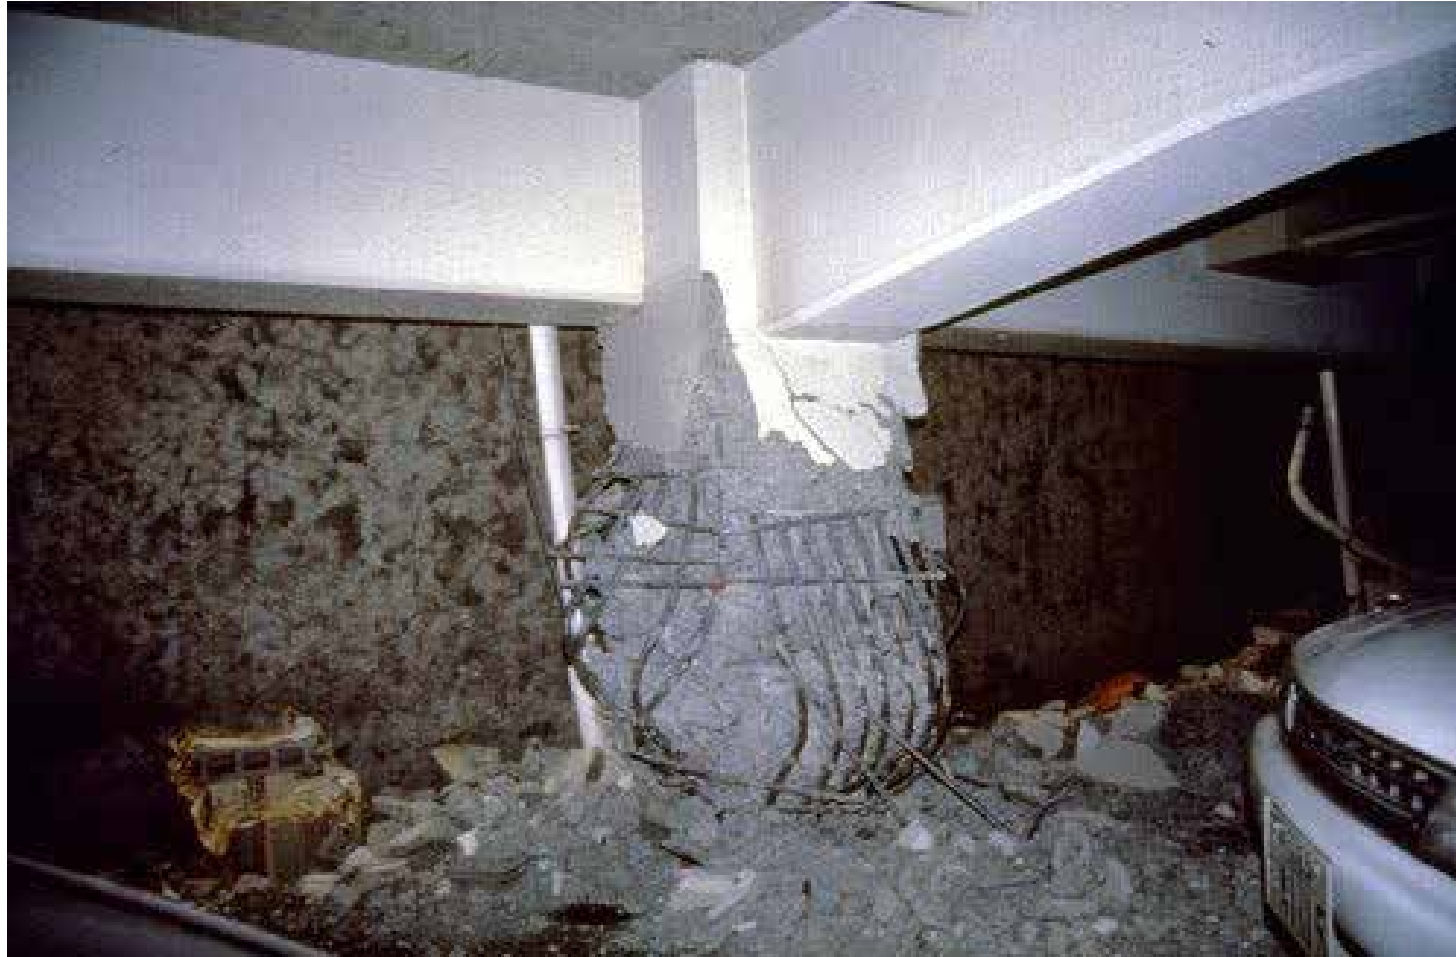
1995 Kobe Japan Mw 6.9

Five-year-old 6-story concrete frame with garage level collapse. Ductile detailing problems in the columns are shown.

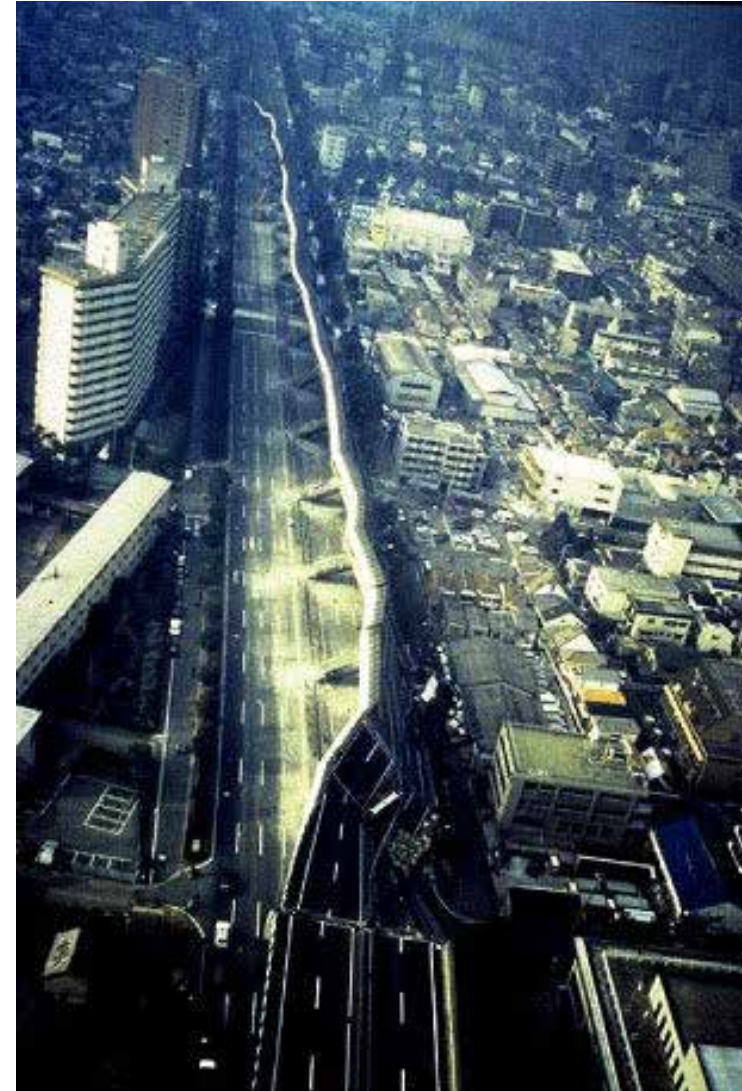
1995 Kobe Japan Mw 6.9

Perhaps the most memorable image flashed around the world after the earthquake, was a bridge on the Hanshin expressway which "rolled over." This is an aerial view of that collapsed section of the Hanshin expressway. This spectacular failure occurred at the location where the superstructure deck changed from steel to concrete.

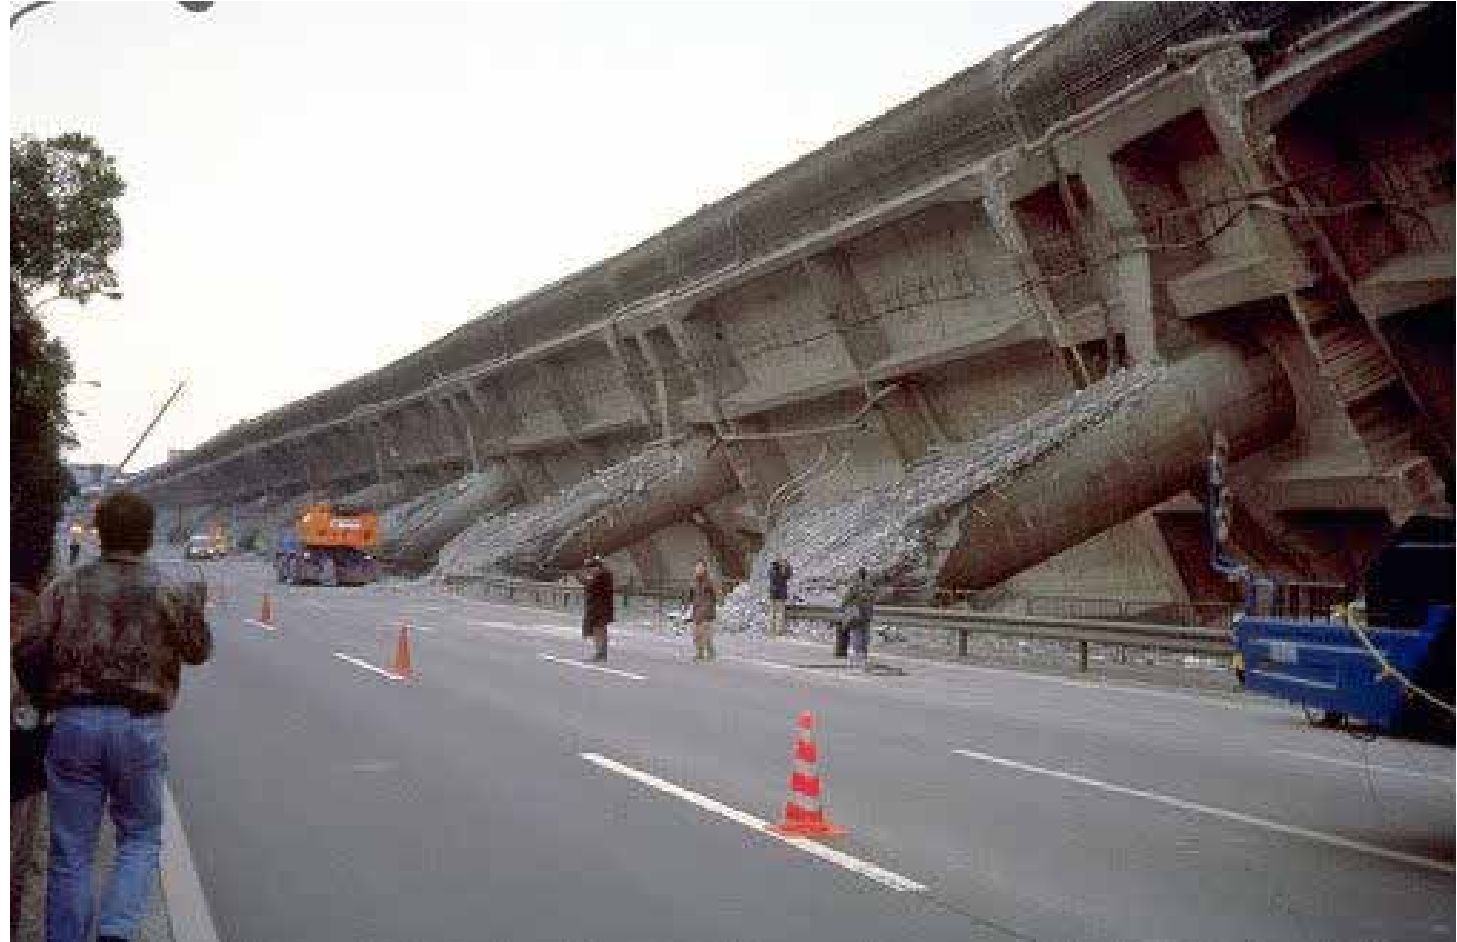
1995 Kobe Japan Mw 6.9

The columns in this segment of the Hanshin expressway are cast monolithically. Between each of these segments there is a simple span deck section which is connected by four bolts across the joint. The whole deck remained intact; none of the segments pulled apart.

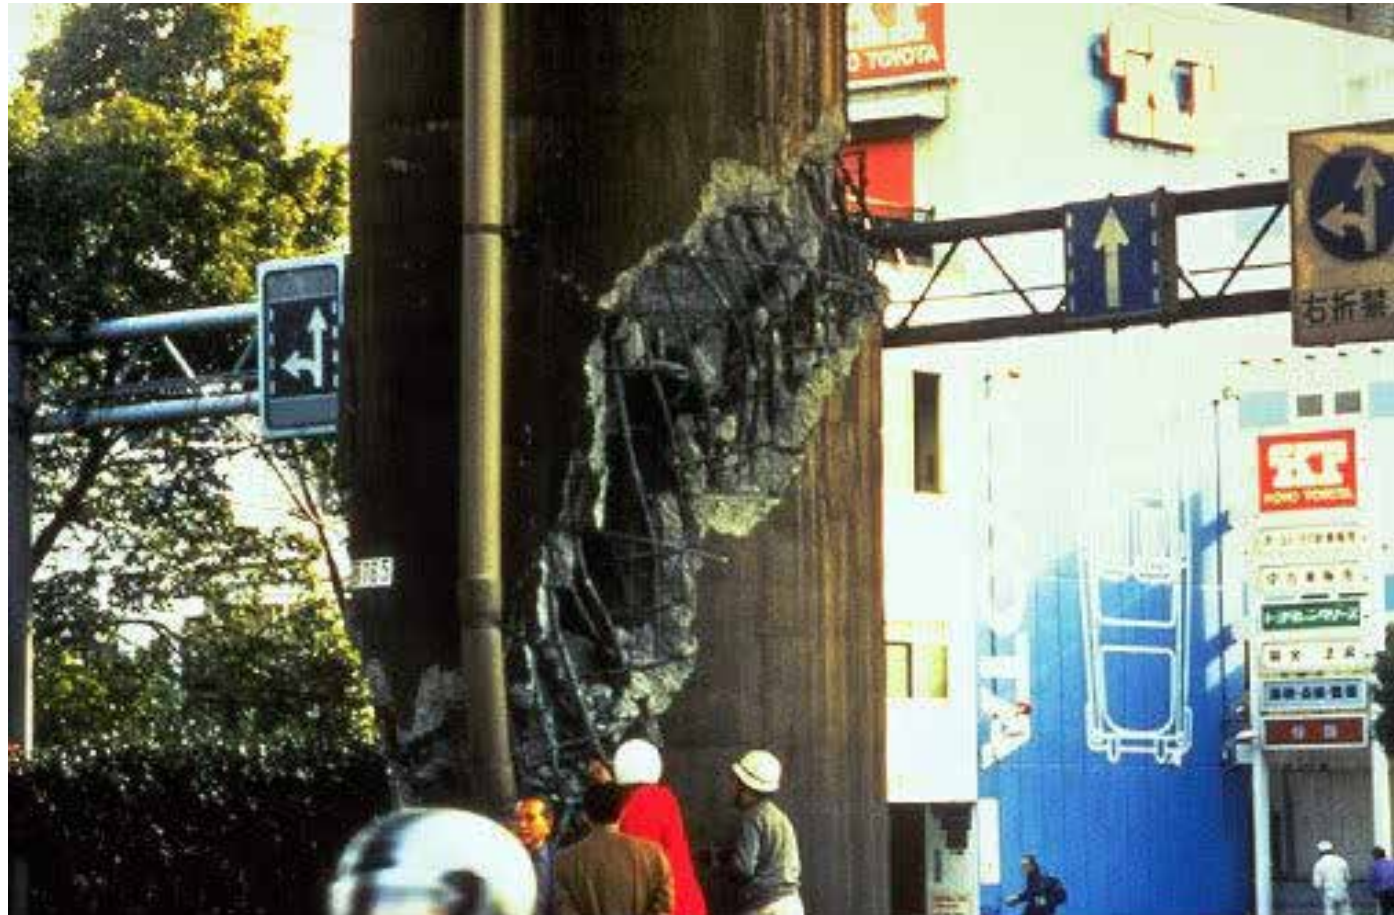
1995 Kobe Japan Mw 6.9

Nearly every column along the elevated Hanshin expressway through Kobe was damaged. For the concrete columns, there was inadequate transverse reinforcement, making the columns very weak in shear, causing the longitudinal steel to birdcage and concrete to fail at low stresses. Note lack of cross ties and large spacing of horizontal ties.
